GLOBAL JOURNAL OF RESEARCHES IN ENGINEERING
CIVIL AND STRUCTURAL ENGINEERING
Volume 13 Issue 5 Version 1.0 Year 2013
Type: Double Blind Peer Reviewed International Research Journal
Publisher: Global Journals Inc. (USA)
Online ISSN: 2249-4596 & Print ISSN: 0975-5861

Studies on Behaviour of Rcc Beam-Column Joint Retrofitted with Basalt Fiber Reinforced Polymer Sheet

By G. Maariappan & R. Singaravadivelan

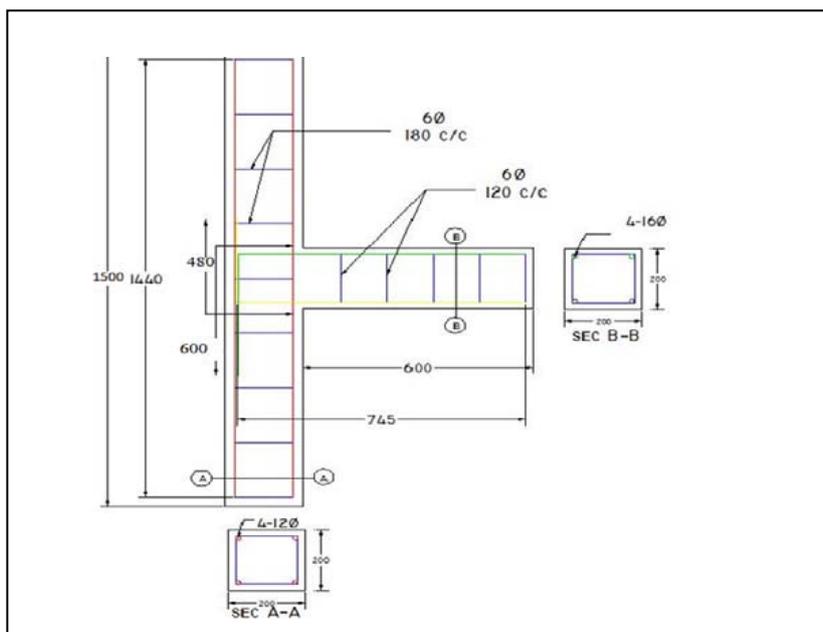
e) Reinforcement Details of Beam Column Joint Specimen

The experimental program consisted of testing of nine reinforced concrete beam-column joint specimens. The columns had a cross section of 200 mm x 200 mm with an overall length of 1500 mm and the beams had a cross section of 200 mm x 200 mm with a cantilevered portion of length 600 mm. In three specimens, the lateral ties in the column are provided with spacing 180 mm c/c as per IS 456:2000. In

remaining three specimens, the lateral ties in the column are provided with spacing 80 mm c/c and 100 mm c/c as per IS 13920:1993. The concrete mix was designed for a target strength of 30 MPa at the age of 28 days. The load carrying capacity of the column was evaluated as 525 kN as per the code IS 456-2000.

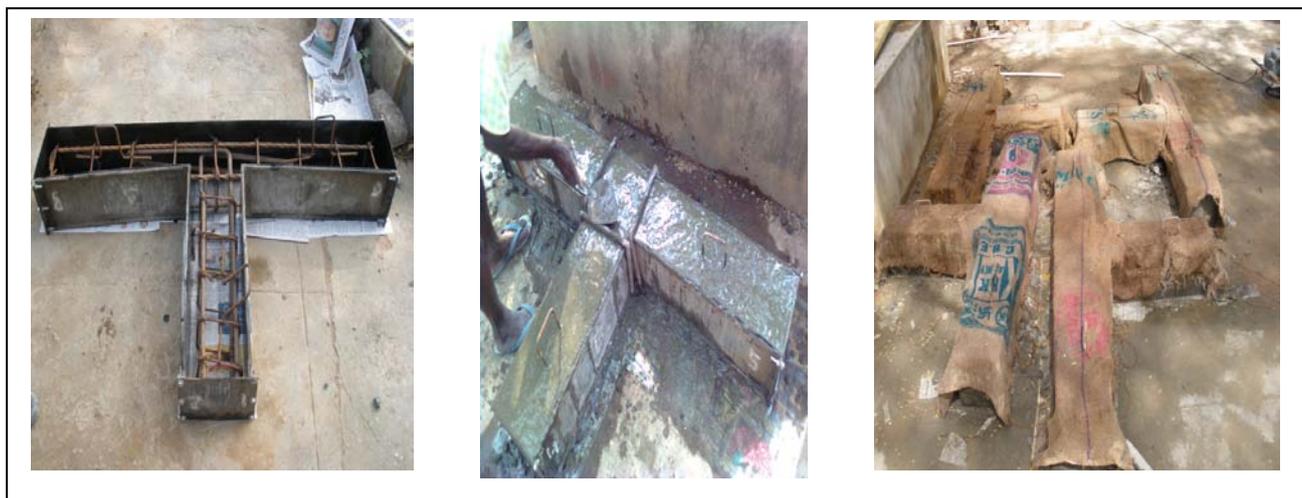
The Reinforced concrete beam column joint specimens were cast using specially fabricated steel moulds. Two moulds were prepared for this purpose.

The fabricated reinforcement steel was placed inside the mould and it is kept in position using cover blocks.

Concrete was mixed manually and poured into the moulds. Care was taken to see that the concrete was properly placed and compacted beneath and also on the sides of the mould using a needle vibrator.

The sides of the mould were removed after 24 hours from time of casting and the test specimens were cured for water using gunny bag coverings. 3 cubes of sizes 150 x 150 x 150 mm were cast along with each test specimen for evaluating the 28day compressive strength of concrete. Figure describes the above mentioned casting and curing operations.

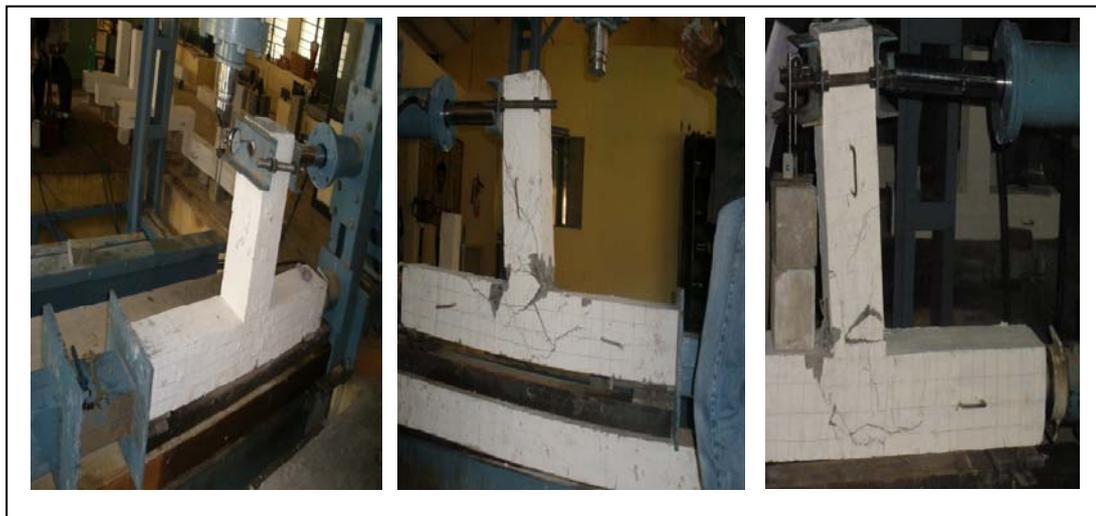
The RC beam-column joint specimens were tested using loading frame in the structural laboratory of

Karunya University. A push-pull jack was set up in the structural laboratory. Both the column ends were provided with hinged boundary conditions. At one of the column ends the axial load was applied by using hydraulic jack of 500 kN capacity which has a load measuring arrangement fitted to it.

A transverse load was applied at the free end of the beam by using a push pull jack. A deflectometer was placed on the other side of the beam which shows the deflection that occurs at the point of application of load on the beam. The testing involves pushing of the beam using the push pull jack by applying the load in the pushing direction up to control deflection of 75mm.

Then the pulling load was applied until the beam comes back to its original position. So, one cycle of load reversal was applied to the test specimens. i.e. the beam was pushed from the normal position, then pulled to the normal position, then it was pulled back from the normal position and again pushed back towards the normal position.

The deflectometer readings were noted down at particular load intervals and the deflection of the beam was determined. Typical view of test setup is shown in figure.

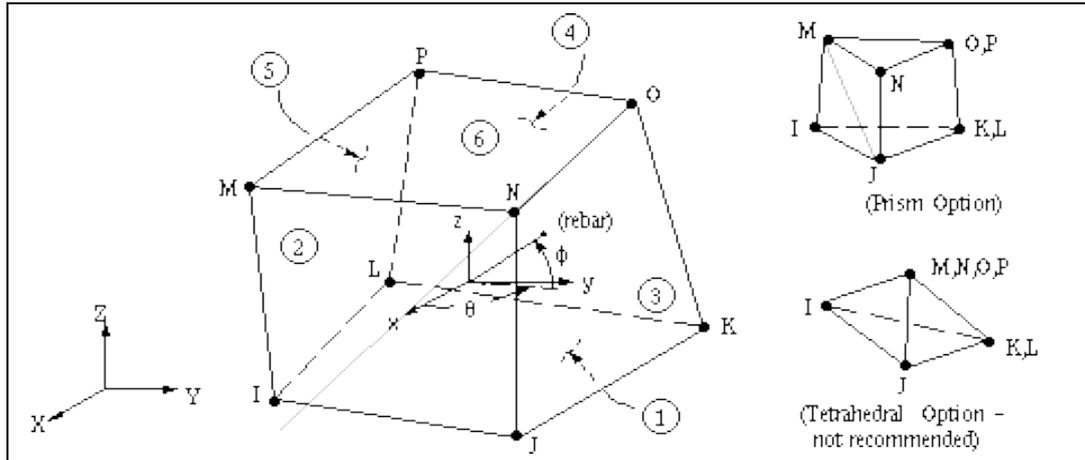
Figure : Solid 65 Element

SOLID 65 elements were used to model reinforced concrete problems or reinforced composite materials (FRP). This element has eight nodes each node having three translational degrees of freedom in the nodal X, Y & Z directions as shown in Figure 5.5. The

Solid 65 may be used to analyse cracking in tension and crushing in compression and solid 45 element has stress stiffening, large deflection, plasticity, large strain capabilities, creep etc. The element may be used to analyse cracking in tension and crushing in compression. Up to three rebar specifications may be defined. The typical solid 65 element was shown in fig.

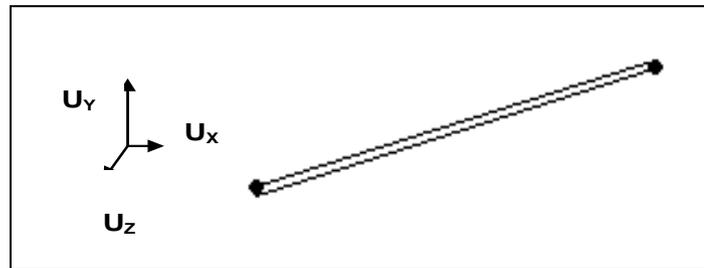
LINK 8 Elements

Link 8 is a Spar Element, which may be used in a variety of engineering applications. Depending upon the applications, the element may be thought of as a truss element, cable element, reinforcing bar and

bolt. The three-dimensional spar element has two nodes and each node has three translational degrees of freedom. This element is capable of plasticity, creep, swelling and stress stiffening effects.

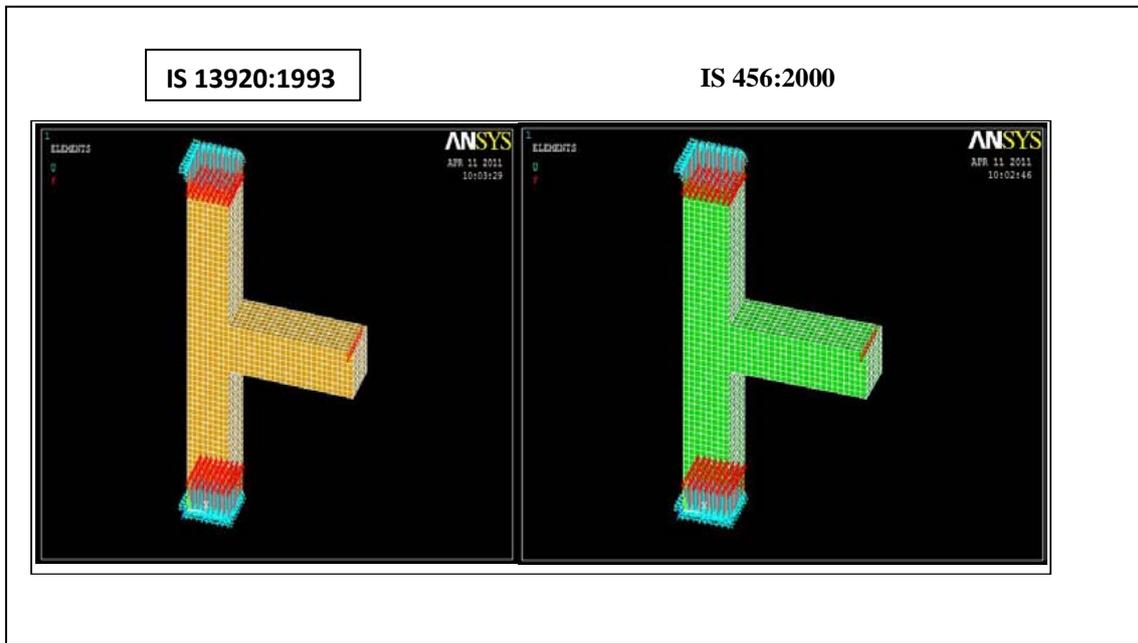
Loading arrangements and boundary condition of Beam-Column Joints

Displacement boundary conditions are needed to constrain the model to get a unique solution. To ensure that the model acts the same way as the experimental beam, boundary conditions need to be applied at points of symmetry, and where the supports and loadings exist. Both ends of the column were

provided hinged boundary condition. A lateral load was applied at the free end of the beam. The load applied in model which had detail as per code IS 456:2000 was 23 kN. Similarly in model which had details as per code 13920:1993 ,the load applied was 26 kN. The comparative result were given in table.
