**Advanced Concept Concrete Using Basalt  
Fiber/BF Composite Rebar Reinforcement**

Final Report for Highway-IDEA Project 86

Vladimir B. Brik,  
Research & Technology Corp., Madison, WI

***February 2003***

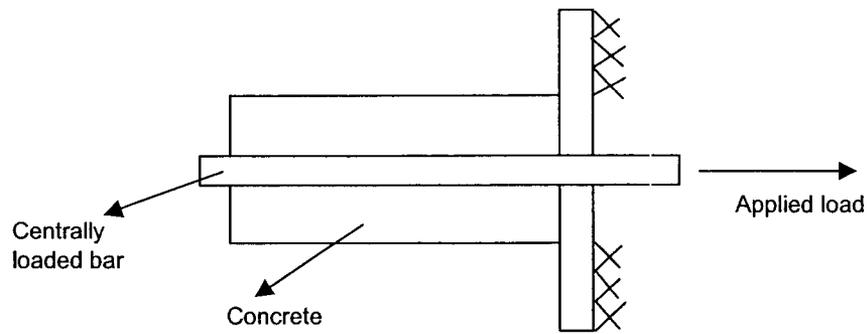
**Pullout Test**

There are several tests that can determine the bond quality of reinforcing element. One of these is the pullout test (See figure below). In this test, the concrete is subjected to compression and the reinforcing bar is subjected to tension, and both the bar and the surrounding concrete are subjected to the same stress.

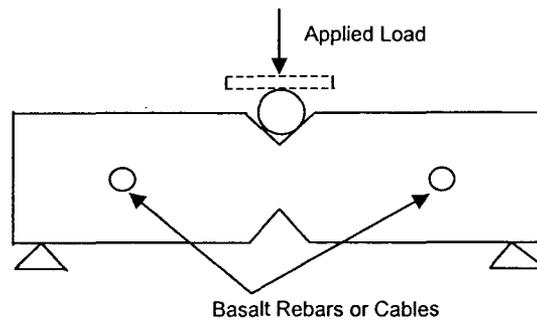
**Breaking of the Horizontal Specimen**

**4.1.2 Specimen Preparation:** The horizontally reinforced specimen was made by placing the concrete in four layers of approximately equal thickness and rodded 25 times with the tamping rod. The horizontally embedded bar specimens, when they were between 7 and 14 days old, were broken in half in flexure to form two 152.4 mm (6-in.) cubes. To do this, the specimen was set up as a simple beam with center-point loading in accordance with ASTM C 293 [5] with two triangular grooves in the upper and lower faces of the beam at midspan. The load was applied to a 19 mm (3/4-in.) diameter bar laid in the upper groove and continued until fracture occurred, as shown in the figure below. During the operation, care was taken not to strike or disturb the reinforcing bars.

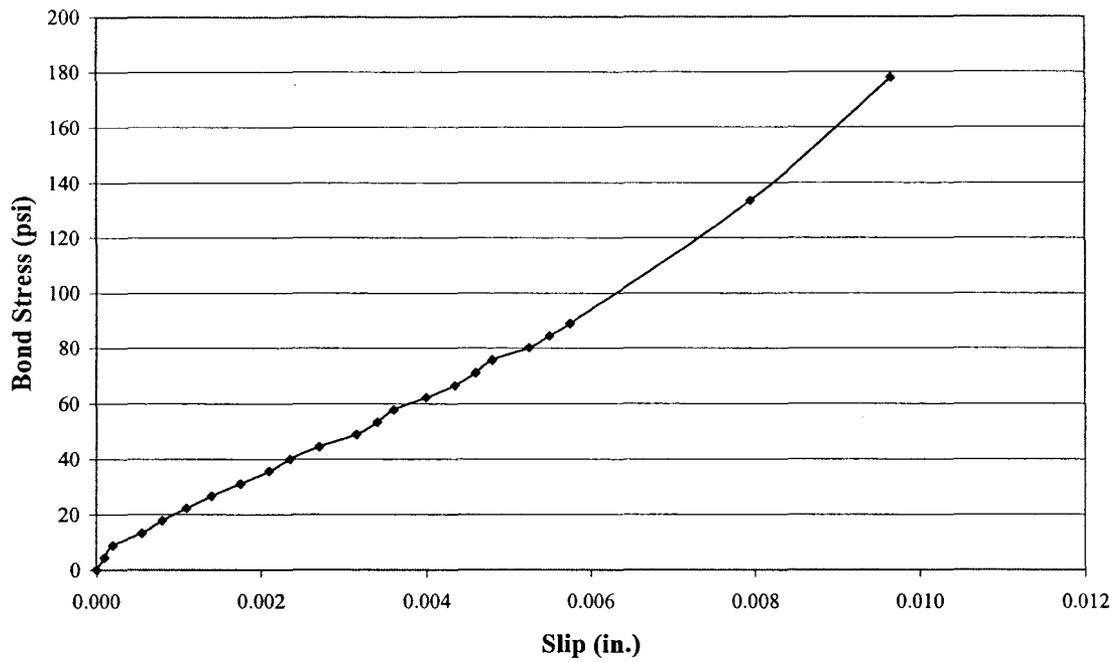
**Fig. 1:** Bond stress Vs. slip for the plain basalt rebar in the lower horizontal position.

*4.1.8 Test Results and Discussions:* First the plain basalt rebar reinforced specimens were tested for the bond strength at an age of 21 days. As the load was applied the plain basalt rebars started slipping and there was no bond between the reinforcement and the concrete (Photo 2-3, Appendix B). It was also found out that the grip of the testing machine was slipping i.e., it was not holding the bar properly as the basalt fibers in the bar were crushed and powdered. There was also a slip in the anchoring end leaving a scratch mark on the bar. Therefore, the anchorage was done using a chuck, which held the specimen in its place at the anchoring end. The specimen was then tested and the plain basalt bar slipped and the marks of concrete were distinctly seen on the bar.

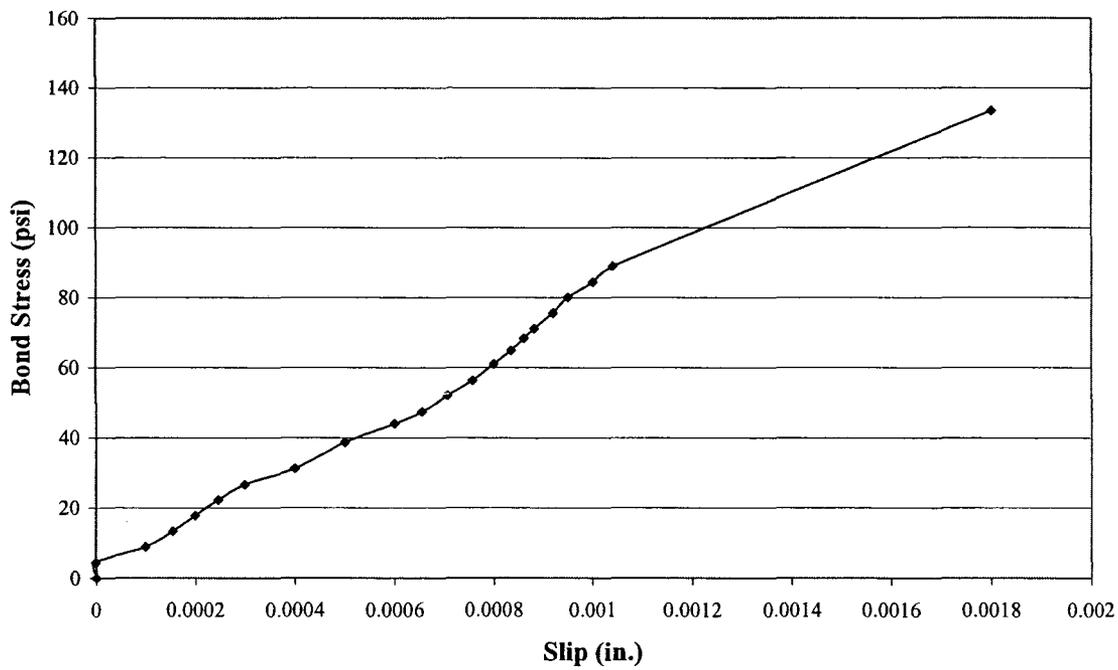
**Fig. 2:** Bond stress Vs. slip for the plain basalt rebar in the upper horizontal position.

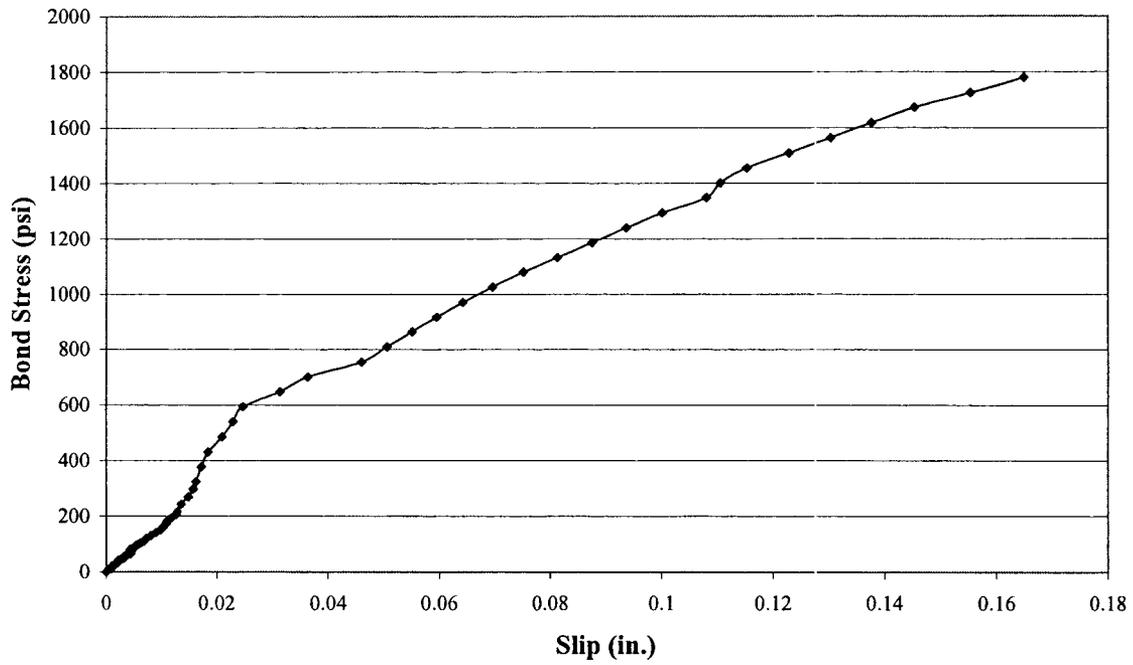
**Fig. 3:** Bond stress Vs. slip for the 4 - slot basalt rebar in the lower horizontal position.

Then the 4-slot basalt bar was tested with both the lower and upper horizontal position of the reinforcement. The 4-slot basalt bar did not slip and hence there was no bond failure. But the basalt bar itself failed due to tension failure. The failure was brittle. The basalt fibers at the failed end can be seen clearly in the photographs shown (Photo 4-5, Appendix B). The 8-slot basalt bar also failed in a similar manner to that of 4-slot basalt bar (Photo 6, Appendix B).

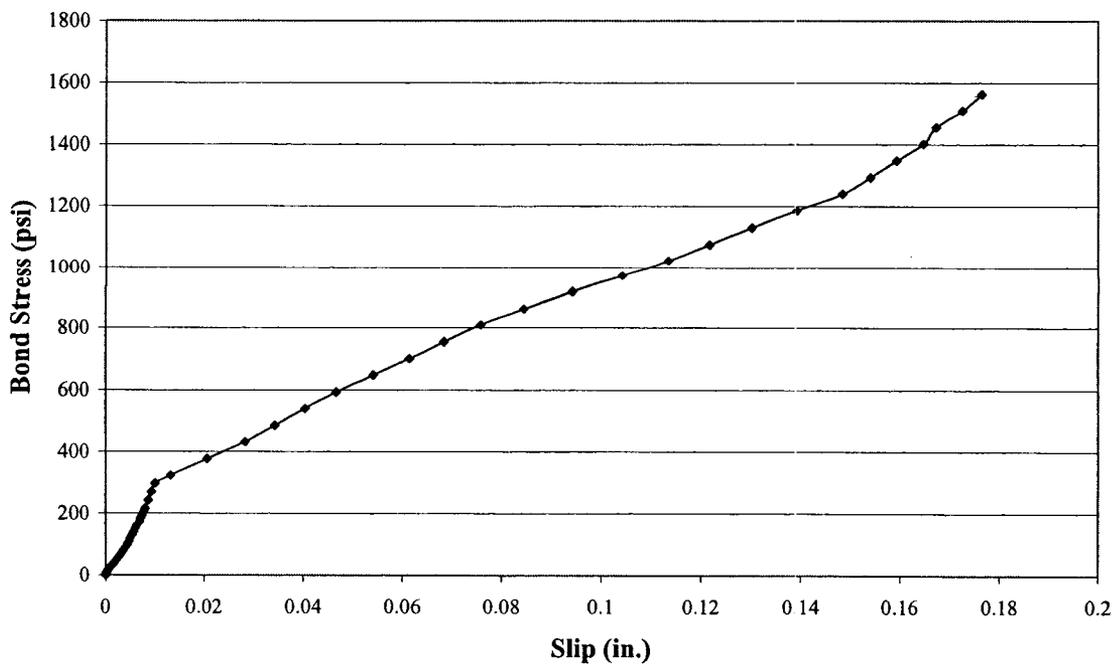
**Fig. 4:** Bond stress Vs. slip for the 4 - slot basalt rebar in the upper horizontal position.

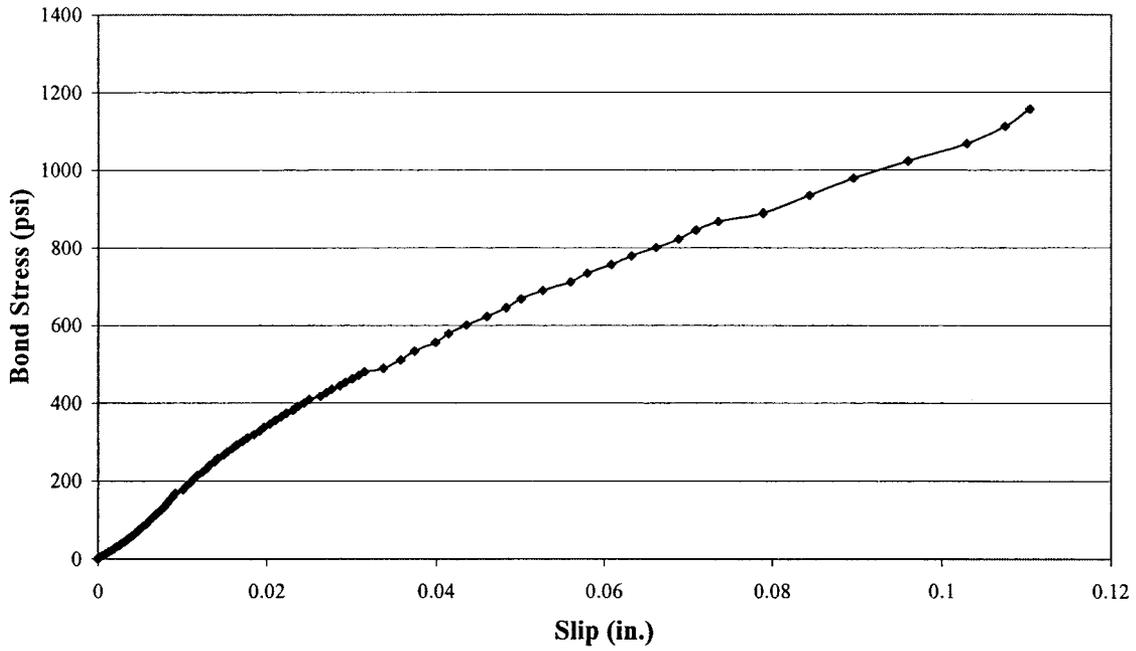
**Fig. 5:** Bond stress Vs. slip for the 8 - slot basalt rebar in the lower horizontal position.

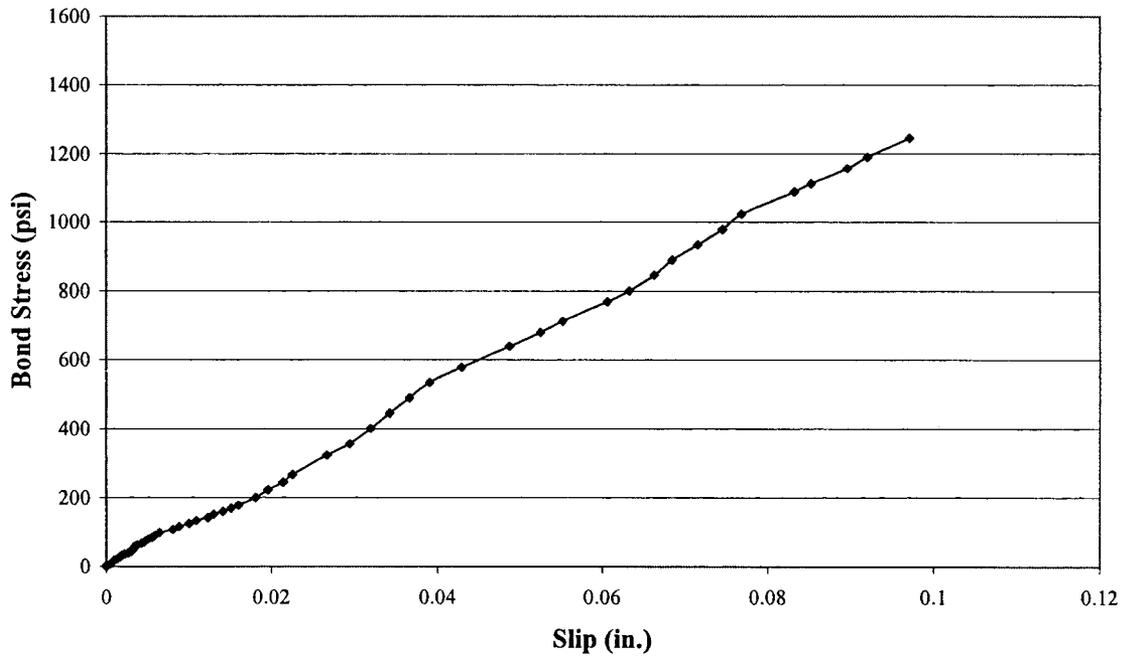
**Fig. 6:** Bond stress Vs. slip for the 8 - slot basalt rebar in the upper horizontal position.

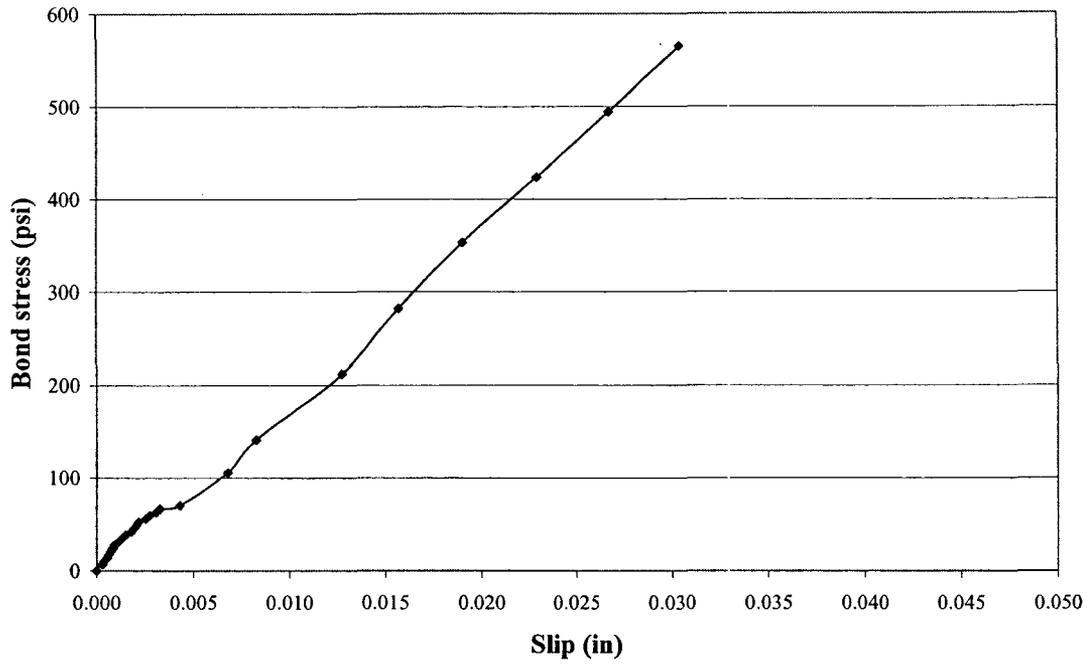
**Fig. 7:** Bond stress Vs. slip for the control mix specimen with the steel reinforcement in the lower horizontal position.

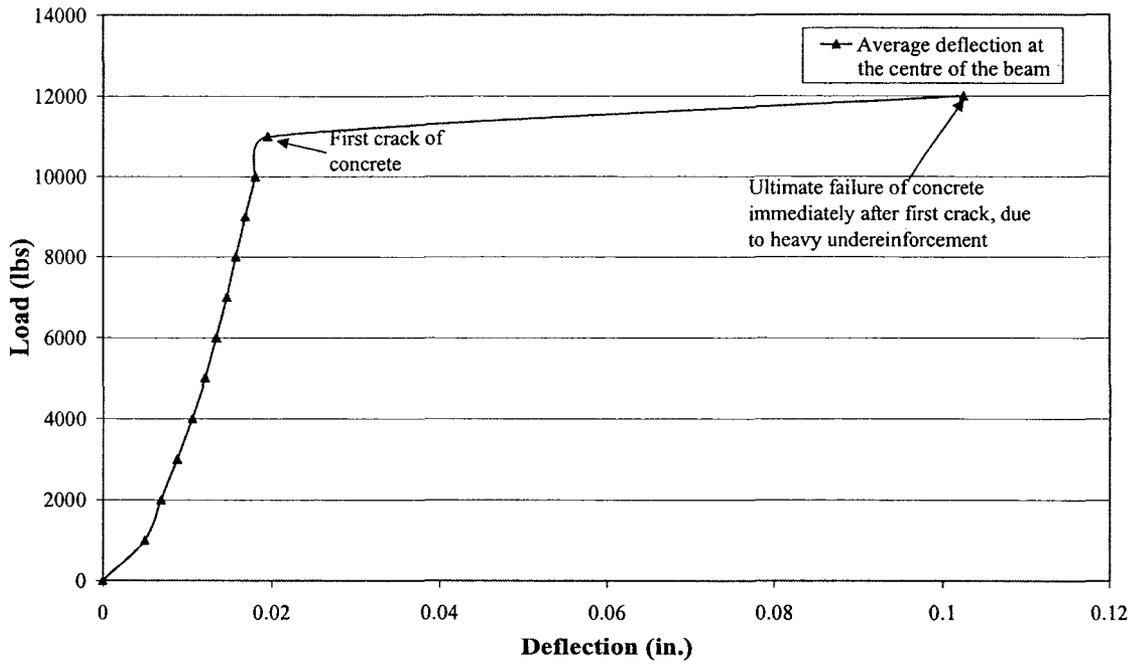
**Fig. 9:** Load Vs. Deflection Graph for Basalt Beam (BRC-1).

Two extremely under reinforced beams were tested to see whether adequate bond was developed between the rebar and concrete. The reinforcement provided for one beam was less than the minimum required according to ACI code 318. Another beam was provided with the ACI recommended minimum reinforcement. For both beams deflections were measured with the help of LVDT's. Strain readings were measured using electrical resistance strain gauges. Both strain and deflection readings were recorded by a data acquisition system (MEGADAC). Both beams were tested in flexure after the 28-day curing period. A development length of 203.2 mm (8 in.) was provided for both beams. The length between the two-point loading was 304.8 mm (12 inch). Beam BRC-1 was reinforced with basalt cables (3.25 mm [0.128 in. dia.]). Strain gauge was placed on the compression side of the beam for measuring the concrete strain. Since the rebars used for BRC-1, had more corrugations on the surface, the strain gauge could not be placed on the rod. The first crack occurred at the calculated cracking moment (Table 2). After first crack, the beam failed suddenly breaking into two pieces, because the beam was extremely under reinforced (Photos 21-22, Appendix B). The rebar broke without slipping, which indicated that there was good bond between the rebar and the concrete. The load vs. deflection and the load vs. concrete strain are shown in Figs. 9 and 10 respectively.

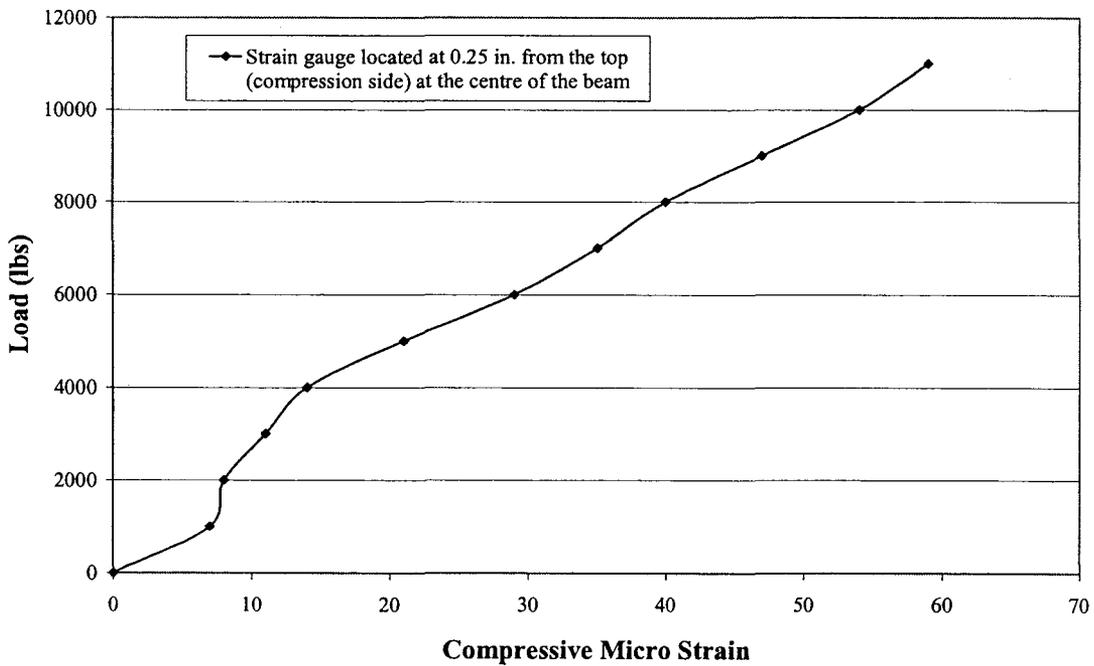
**Fig. 10:** Load Vs. Concrete Strain for Basalt Beam (BRC-1).

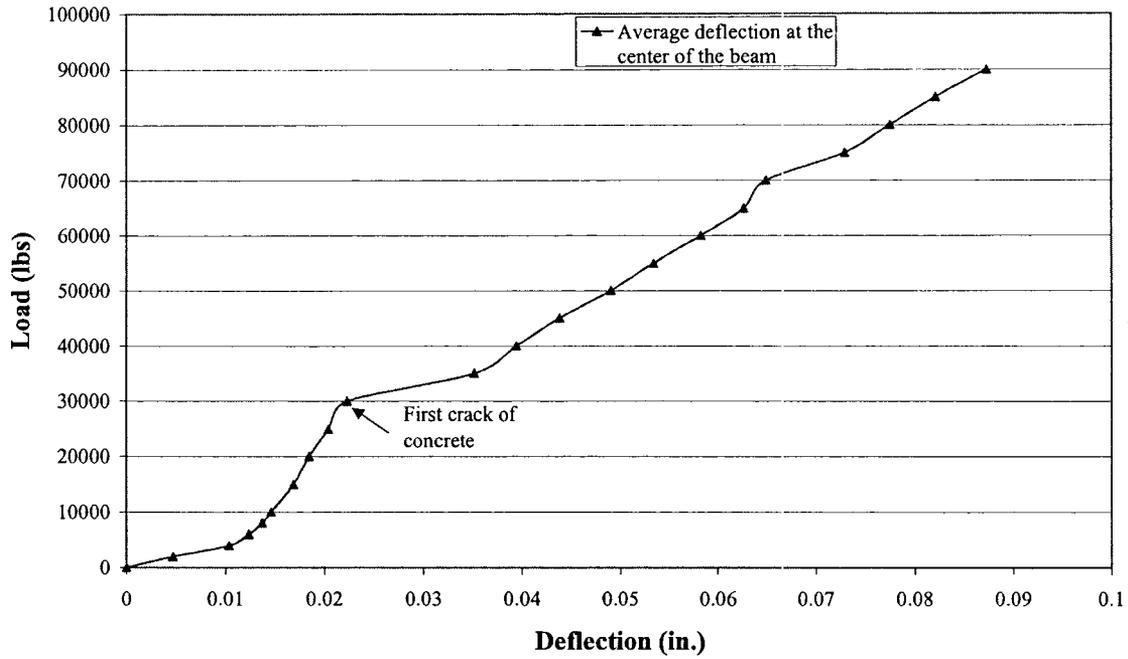
**Fig. 11: Load Vs. Deflection Graph for Basalt Beam (BRC-2).**

Beam BRC-2 was under reinforced with the minimum ACI 318 recommended reinforcement. A strain gauge was placed on the compression side of the beam, and one strain gauge was placed on the 4-slot rebar (slot dia: 10.4 mm [0.41 in.]) in the tension side. The beam first had a flexural crack at 85% of the calculated cracking moment (Table 2), but ultimately the beam failed in shear (Photos 17-19, Appendix B). This was attributed to the fact that the beam was very deep. Even though the beam failed in shear, it took 88% of the calculated ultimate moment (Table 2). The beam did not fail due to slip of the rebar, which indicated that there was a good bond between the 4-slot rebar and the concrete. If the beam had failed in flexure rather than in shear the beam would have definitely carried more ultimate moment than the calculated moment. The load vs. deflection, load vs. concrete strain and basalt rebar strain are shown in

Figs. 11 to 13 respectively. The overall test results indicated that there was sufficient bond strength and the bars did not slip even after the ultimate load was reached. The measured and calculated ultimate and cracking moments are compared in Table 2. The photographs (Photos 7-22) of the test set-up and the tested beams are shown in Appendix B.

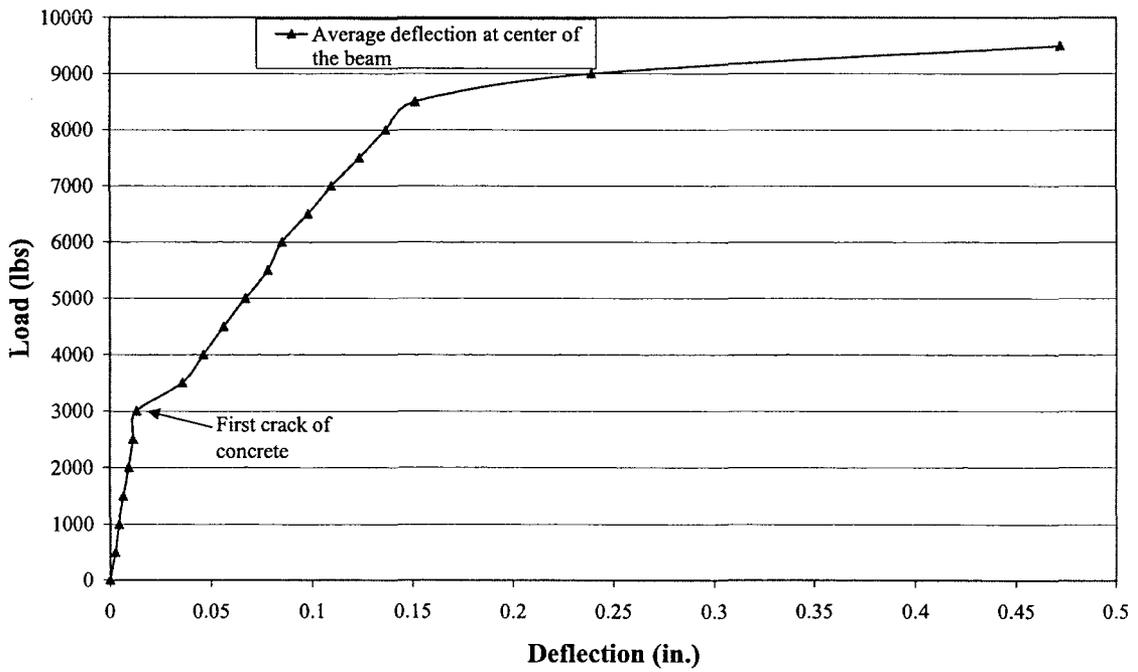
**Fig. 14: Load Vs. Deflection Graph for Basalt Beam (BRC-3).**

Beam BRC-3 was designed as a lightly under reinforced beam with one corrugated basalt rod 8.6 mm (0.34 in. dia) (Photo 23, Appendix B). Strain gauge was placed on the compression side of the beam for measuring the strain in the concrete. Strain gauge was also placed on the rod (tension side of the beam) to determine the strain in the rebar. The first crack occurred at 95% of the calculated cracking moment (Table 2). After first crack the beam took **2.7 times more** moment than the cracking moment (Table 2) indicating a very good bond strength between the rebar and the concrete. The beam failed at 98% of the calculated ultimate moment (Table 2). The load vs. deflection, the load vs. concrete strain and basalt rebar strain are shown in Figs. 14 to 16 respectively. The beam failed primarily in flexure and secondarily in shear (Photos 24-30, Appendix B).

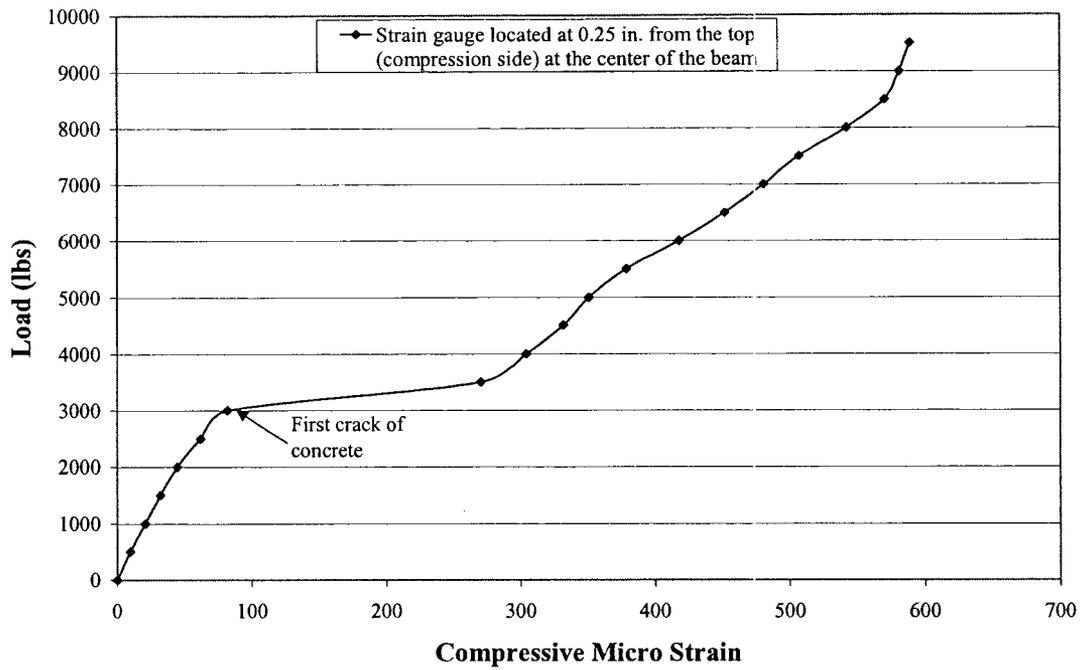
Fig. 15: Load Vs. Concrete Strain for Basalt Beam (BRC-3).

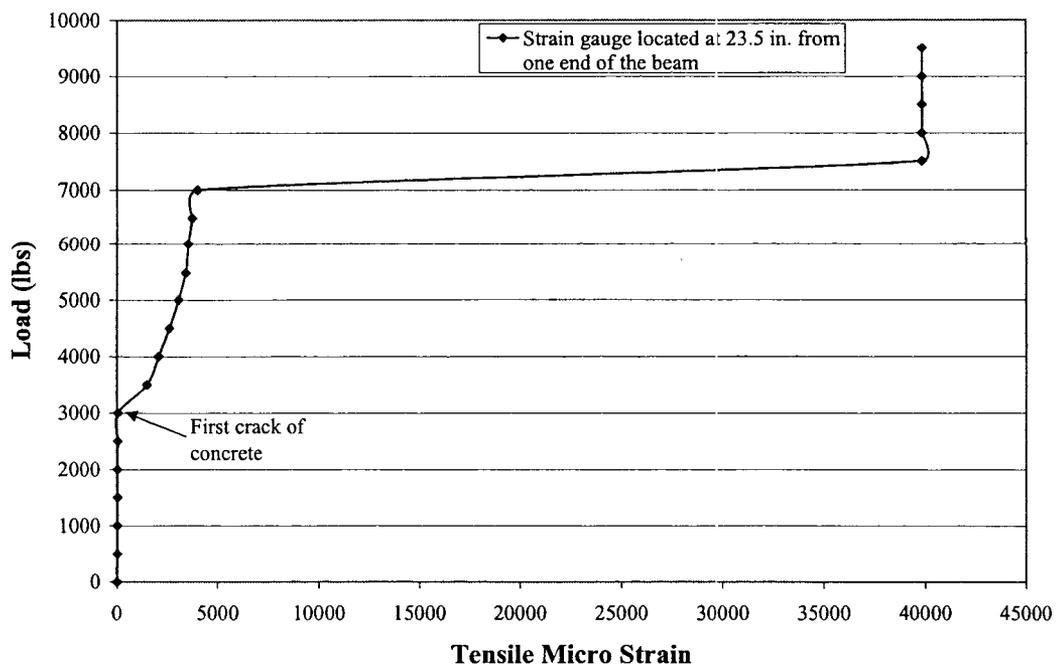
Fig. 16: Load Vs. Basalt Rebar Strain for Basalt Beam (BRC-3).

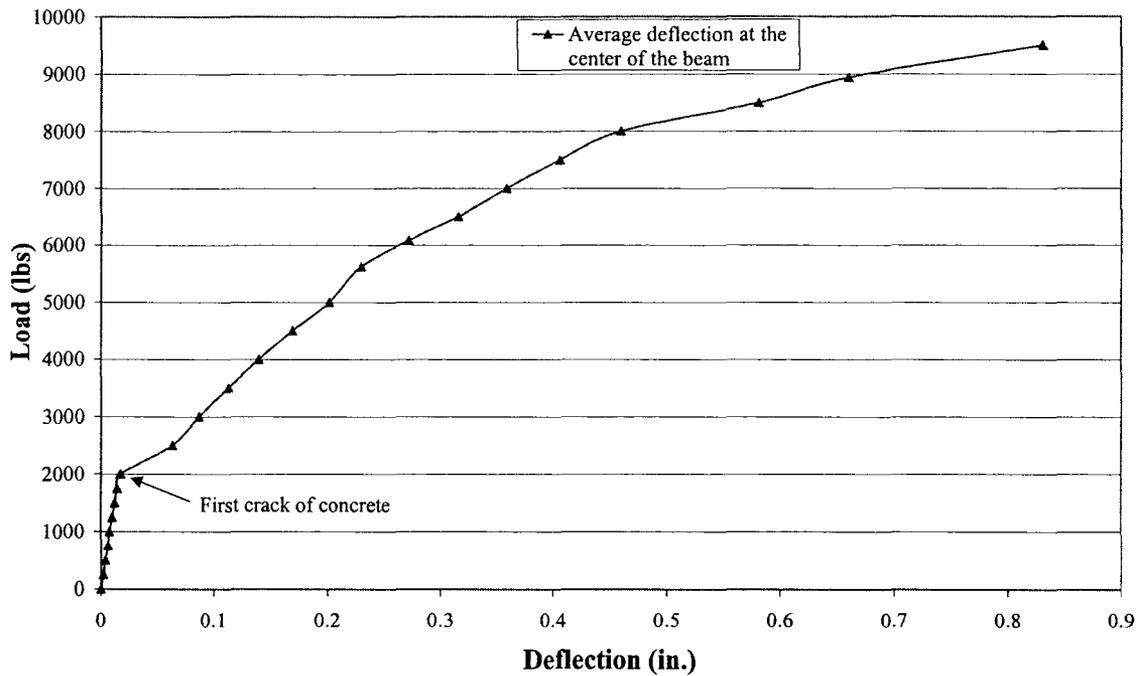
Fig. 17: Load Vs. Deflection Graph for Basalt Beam (BRC-4).

because of the corrugations formed due to twisting the wires. The beam first had a flexural crack at 76% of the calculated cracking moment (Table 2). After first crack the beam took **4.9 times more** moment than the cracking moment (Table 2) indicating a very good bond strength between the rebar and the concrete. The beam failed at 97% of the calculated ultimate moment (Table 2). The beam failed purely in flexure (Photos 33-36, Appendix B). Overall the performance of the beam was good and the wires were split partially at failure indicating good bond strength. The cables did not slip even after the ultimate load was reached. The load vs. deflection and the loads vs. concrete strain are shown in Figs. 17-18 respectively.

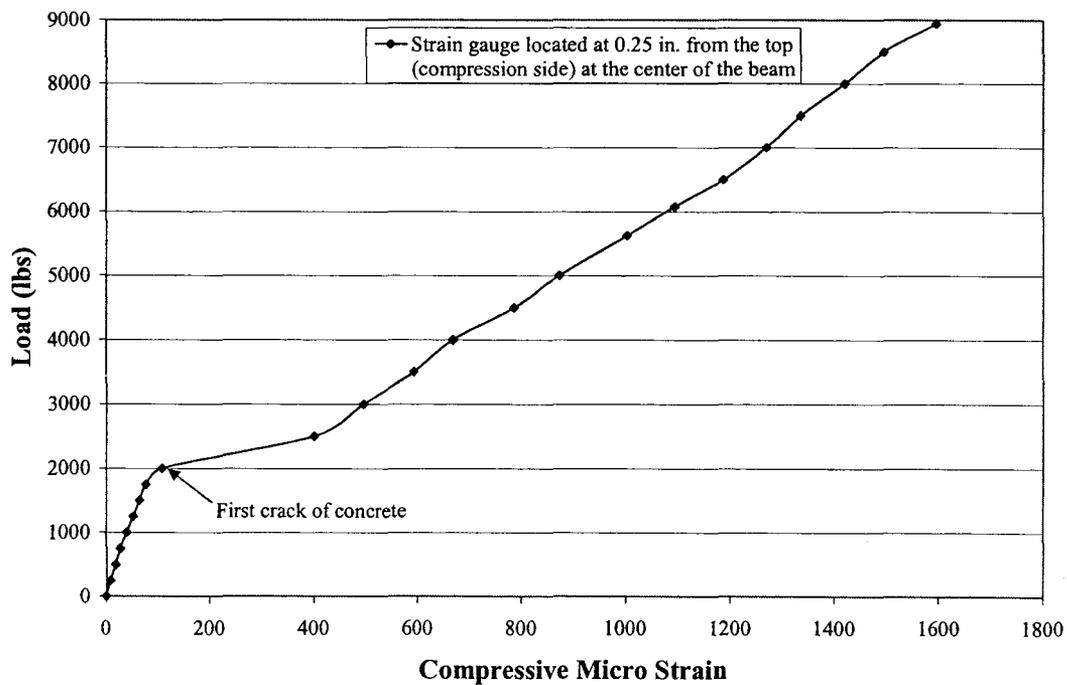
Fig. 18: Load Vs. Concrete Strain for Basalt Beam (BRC-4).

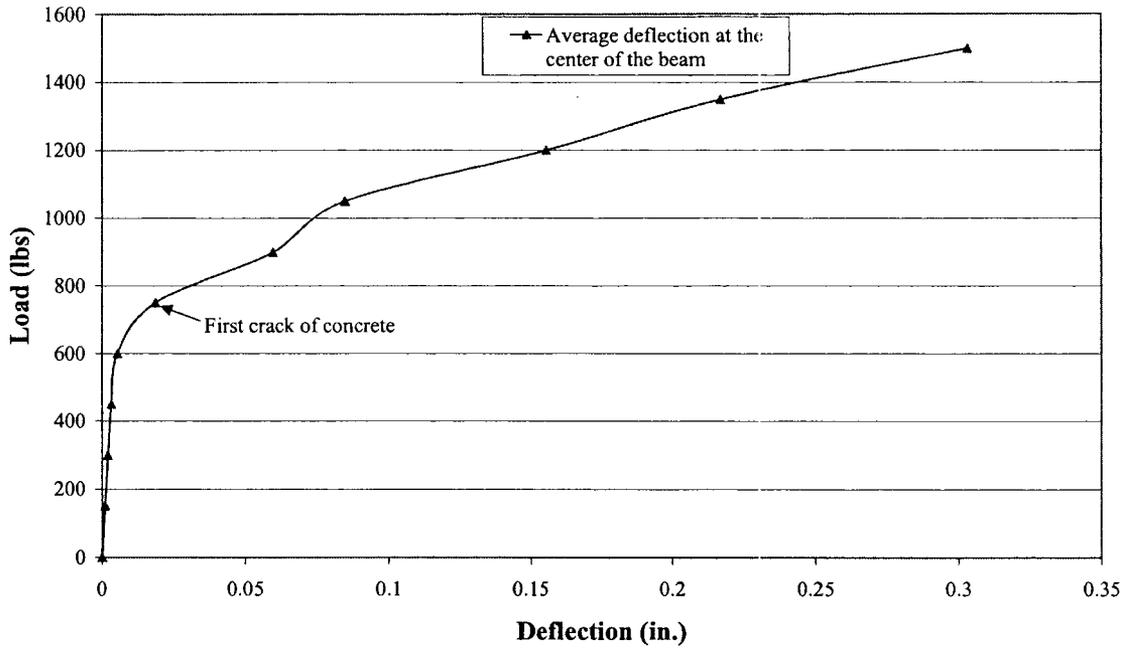
**Fig. 19:** Load Vs. Deflection Graph for Basalt Beam (BRC-5).

Beam BRC-5 was made of three basalt cables of 1041.4 mm (41 in.) length and 3.45 mm (0.136 in.) diameter (Table 1). The beam was under-reinforced. The cables were supplied by the manufacturer (Photo 37, Appendix B), unlike the one used in beam BRC-4 that was made in the laboratory. A strain gauge was placed on the compression side of the beam, and the strain gauge could not be fixed on the rebar, because of the corrugations formed due to twisting the wires. The beam first had a flexural crack at 95% of the calculated cracking moment (Table 2). After the first crack the beam took **2.4 times more** moment (less than the other beams because it was under-reinforced, and the tensile strength of the bar was also less) than the cracking moment (Table 2) indicating a very good bond strength between the rebar and the concrete. The beam took **49% more** than the calculated ultimate moment (Table 2). The beam failed primarily in flexure and secondarily in shear (Photos 38-40, Appendix B). Overall the performance of the beam was good and the cables completely fractured at failure (Photos 41-42, Appendix B), indicating a good bond strength. The cables did not slip even after the ultimate load was reached. The load vs. deflection and the loads vs. concrete strain are shown in Figs. 19-20 respectively.

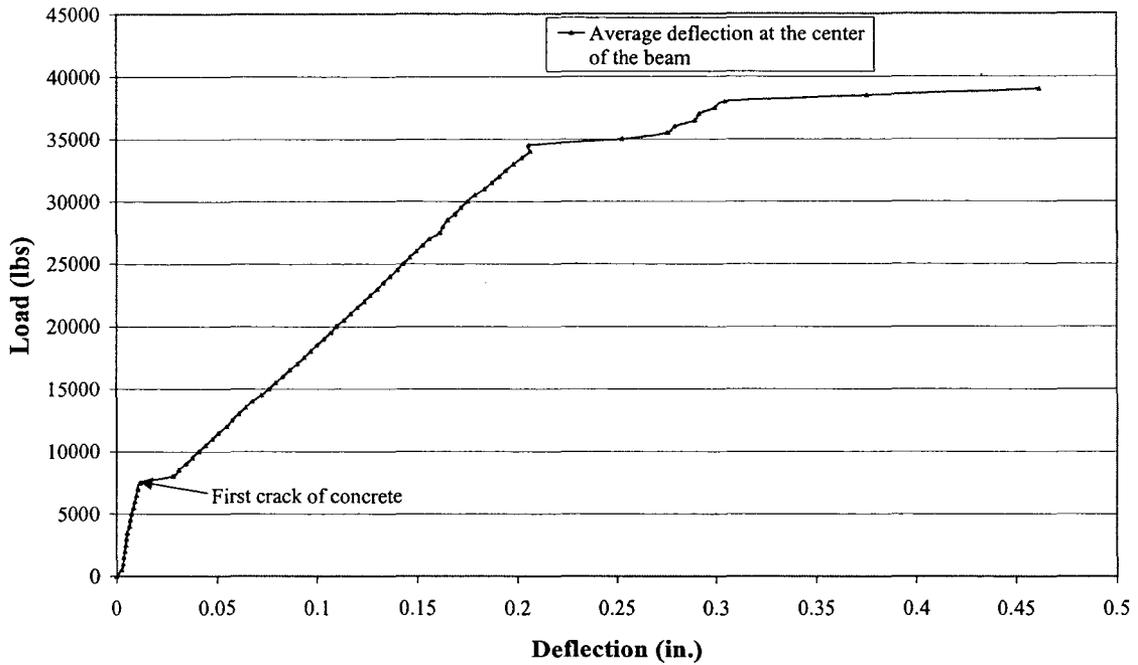
**Fig. 21: Load Vs. Deflection Graph for Basalt Beam (BRC-6).**

Beam BRC-6 was made with two basalt rods of 1219.2 mm (48 in.) length and 9.65 mm (0.38 in.) diameter (Table 1). The beam was lightly under-reinforced. The rods were supplied by the manufacturer and were provided with 1 Fe-Mn-Ni anchors (smart alloys) on each end of the bar to prevent slip (Photos 43,45, Appendix B). A strain gauge was placed on the compression side of the beam, and another strain gauge was also placed on the rebar on the slot to measure the strain in the rebar (Photo 44, Appendix B). The first flexural crack occurred at **4.5% more** than the calculated cracking moment (Table 2). After first crack the beam took **5.1 times more**

moment than the cracking moment (Table 2) indicating a very good bond strength between the rebar and the concrete. The beam took **12% more** than the calculated ultimate moment (Table 2). The beam failed primarily in flexure and secondarily in shear (Photos 46-50, Appendix B). Overall the performance of the beam was very good and the rods did not slip even at failure because of the anchors provided at the ends. The load vs. deflection, the loads vs. concrete strain, and the load vs. basalt rebar strain are shown in Figs. 21-23 respectively.

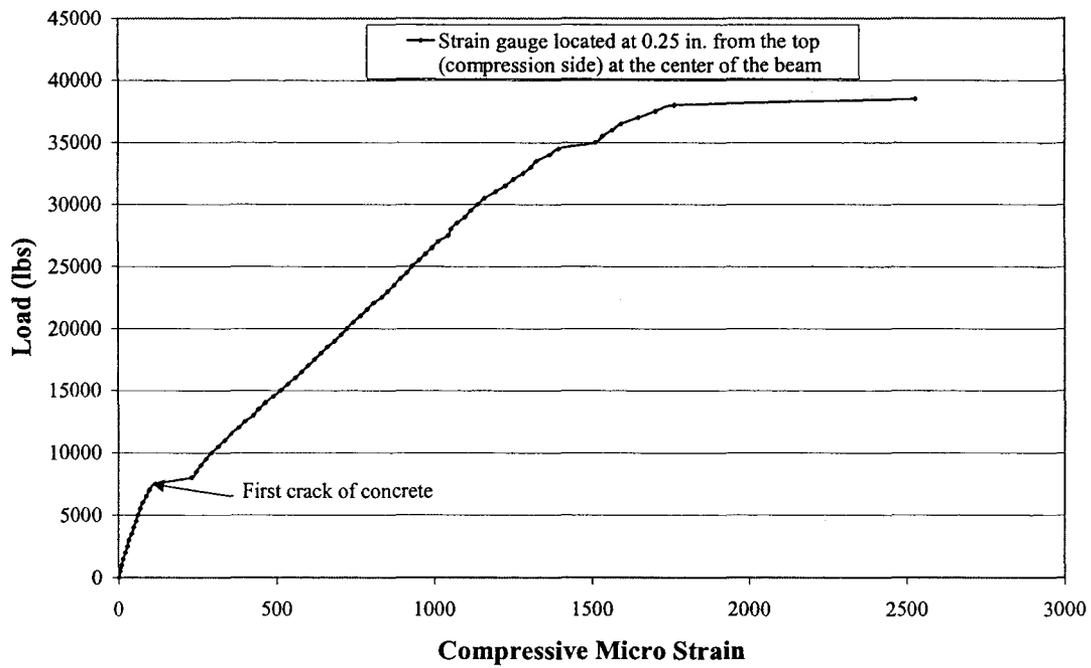
**Fig. 22: Load Vs. Concrete Strain for Basalt Beam (BRC-6).**

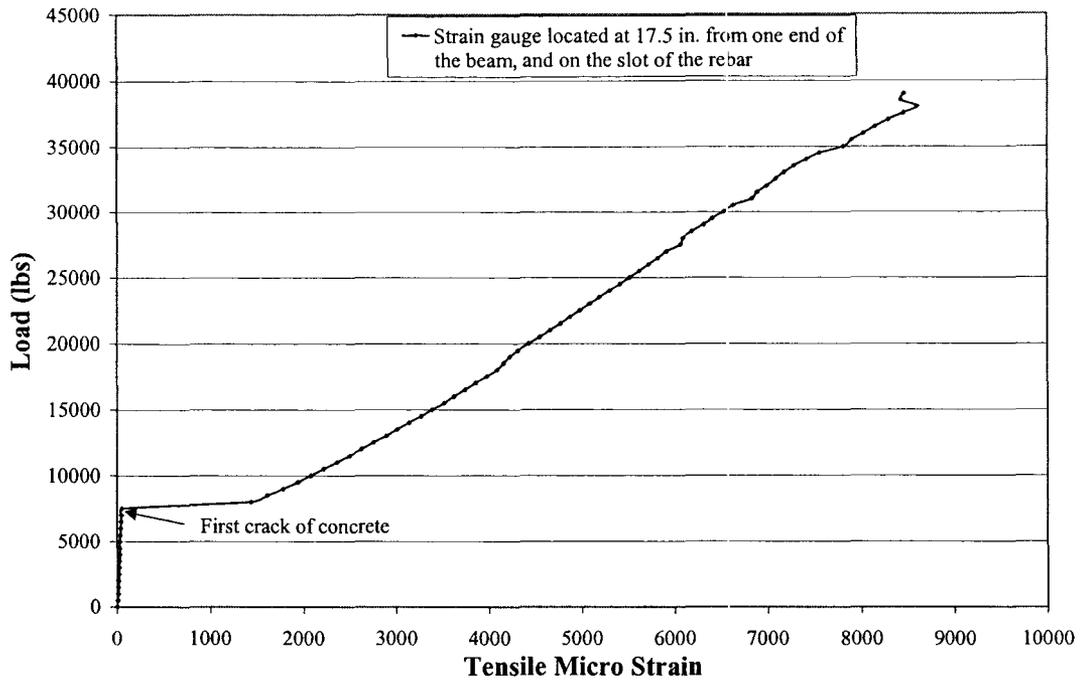
**Fig. 23:** Load Vs. Basalt Rebar Strain for Basalt Beam (BRC-6).

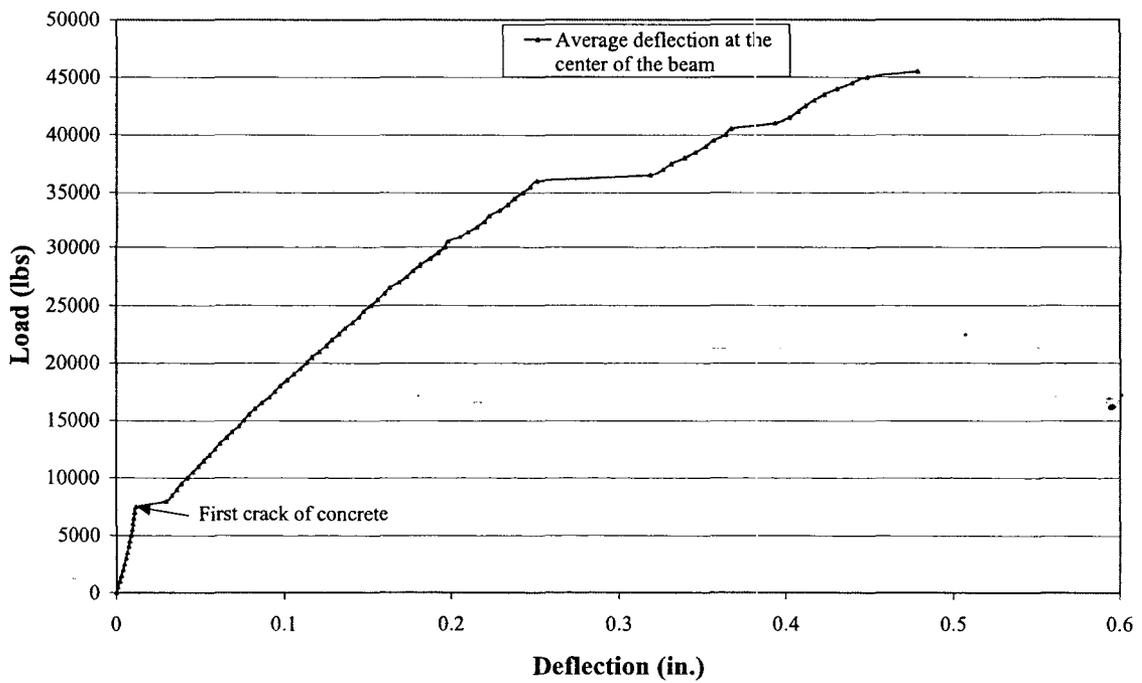
**Fig. 24:** Load Vs. Deflection Graph for Basalt Beam (BRC-7).

Beam BRC-7 was made with two basalt rods of 1219.2 mm (48 in.) length and 10.1 mm (0.399 in.) diameter (Table 1). The beam was lightly under-reinforced. The rods were supplied by the manufacturer and were provided with 2 Ti-Ni (50/50) anchors (smart alloys) on each end of the bar (Photo 51, Appendix B) to prevent slip. A strain gauge was placed on the compression side of the beam, and another strain gauge was also placed on the rebar in the slot to measure the strain in the rebar. The first flexural crack occurred at **7.3% more** than the calculated cracking moment (Table 2). After the first crack the beam took **5.9 times more** moment than the cracking moment (Table 2) indicating a very good bond strength between the rebar and the concrete. The beam took **21% more** than the calculated ultimate moment (Table 2). Of all the beams, this beam performed very well basically because of the anchors and the slots that were provided on the rebar. The beam failed primarily in flexure and secondarily in shear (Photos 52-56, Appendix B). Overall the performance of the beam was very good because of the anchors at the ends. The rods did not slip even after the ultimate load was reached. The load vs. deflection, the loads vs. concrete strain and the load vs. basalt rebar strain are shown in Figs. 24-26 respectively.

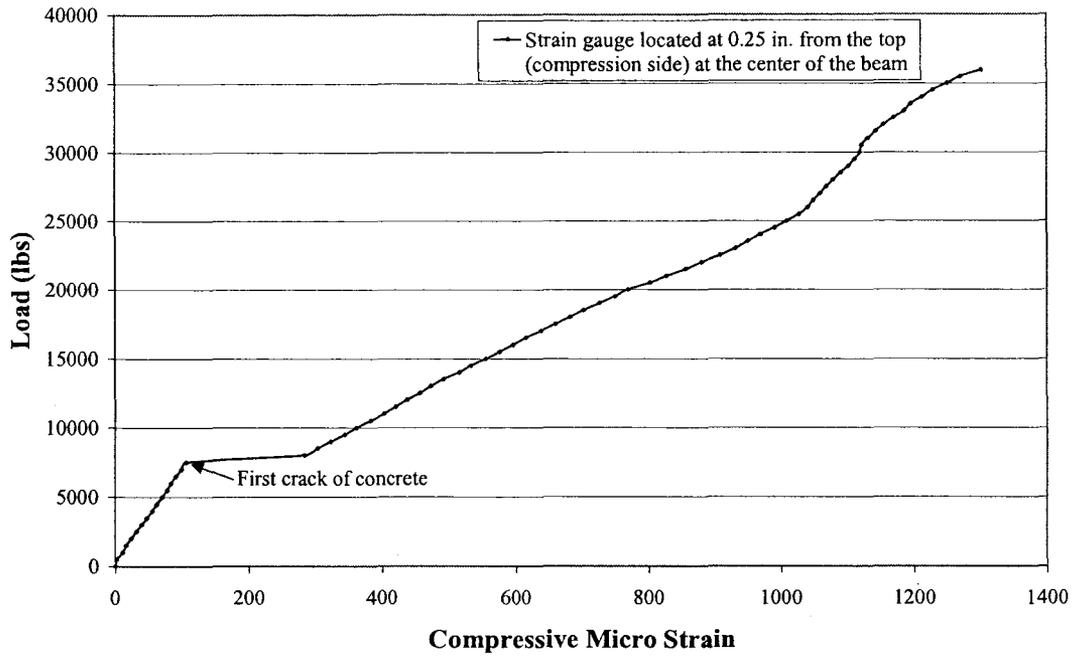
**Fig. 25:** Load Vs. Concrete Strain for Basalt Beam (BRC-7).

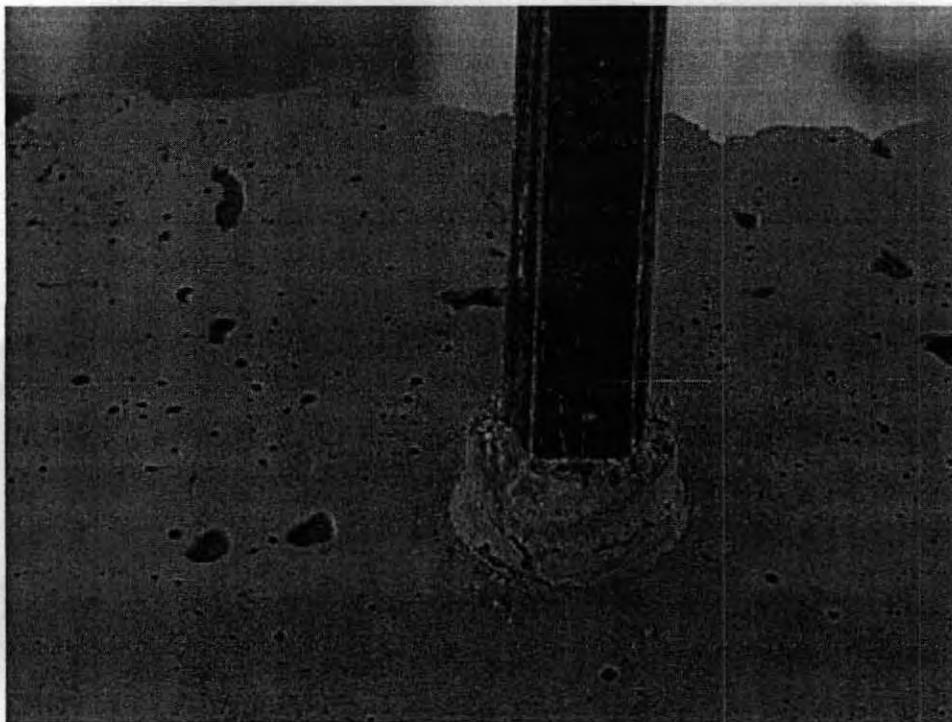
**Photo 2:** The bond failure due to the slip in plain basalt rebar.

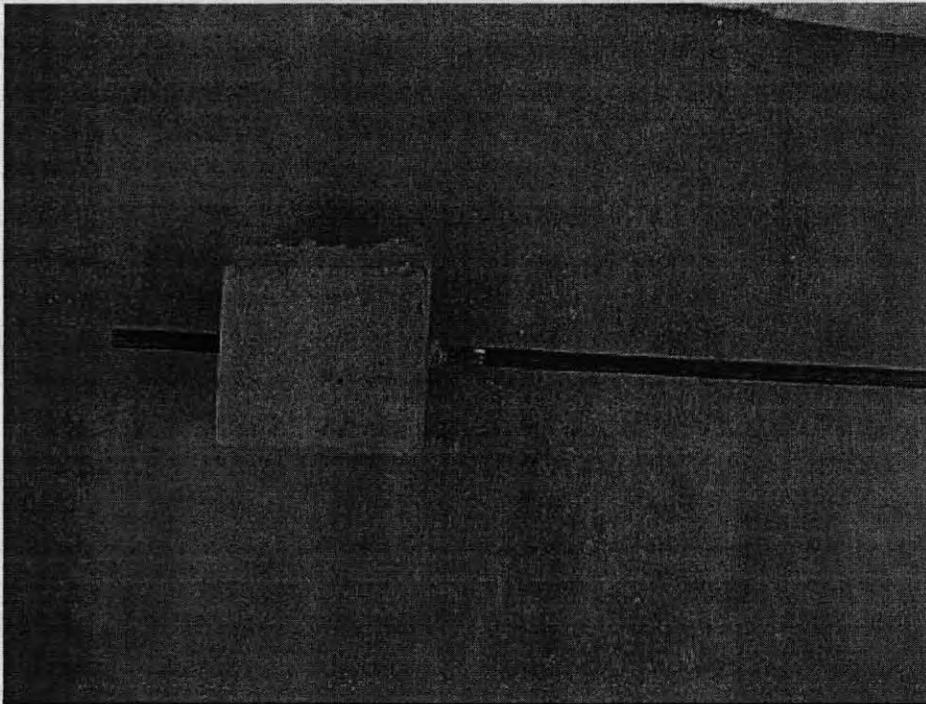
**Photo 3:** The bond failure of plain basalt rebar reinforced specimen due to slip. The slip can be clearly seen in this photo due to the mark of concrete on rebar.

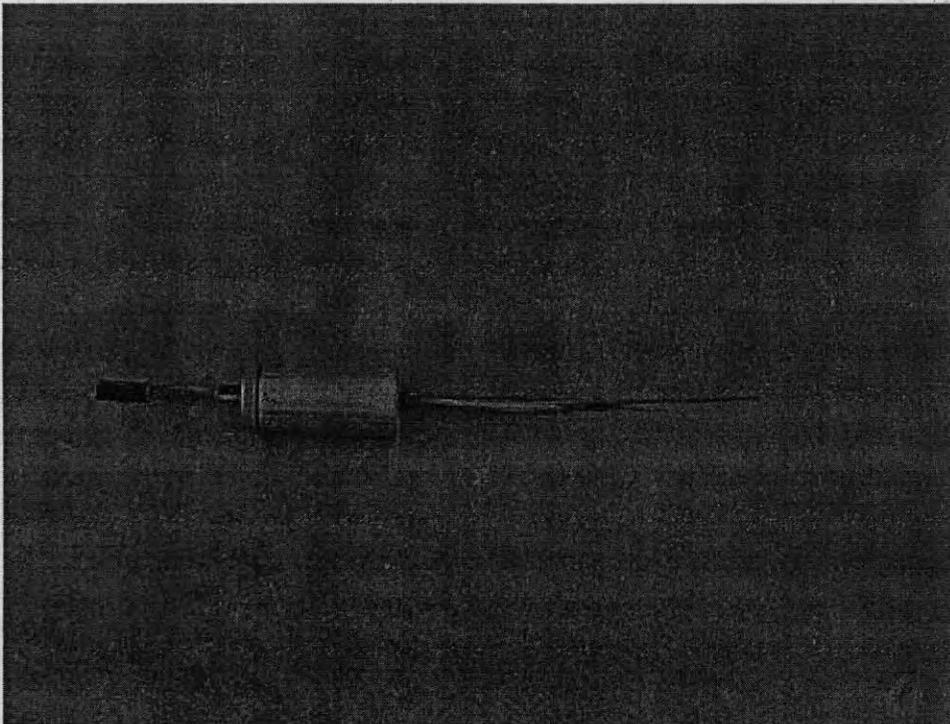
**Photo 4:** The chuck used to anchor the rebar along with the broken rebar.

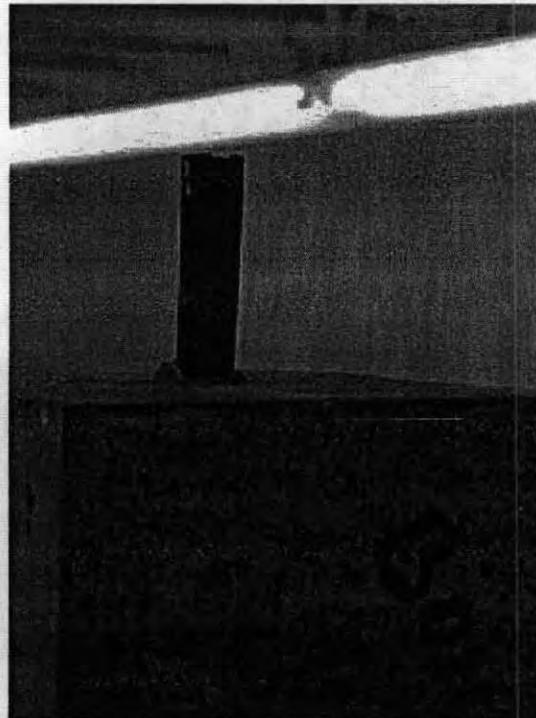
**Photo 6:** The failed 8 – slot basalt rebar in close up. The splitted rebar along with the slip can be seen clearly here.

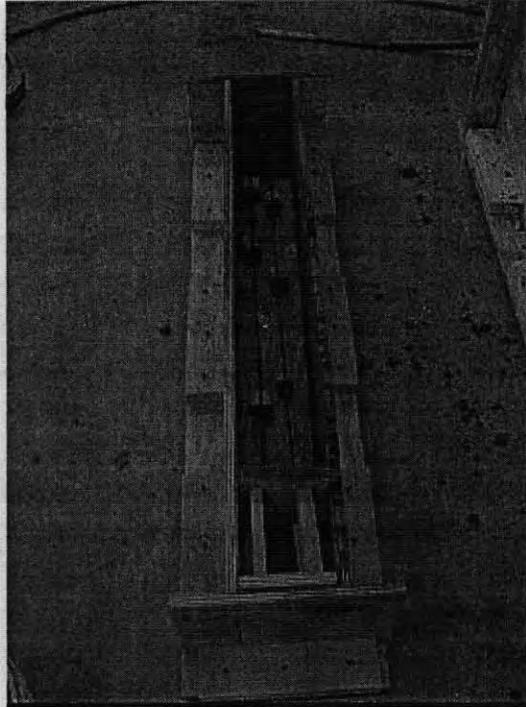
**Photo 7:** BRC-1 beam with the basalt cables with the cover blocks.

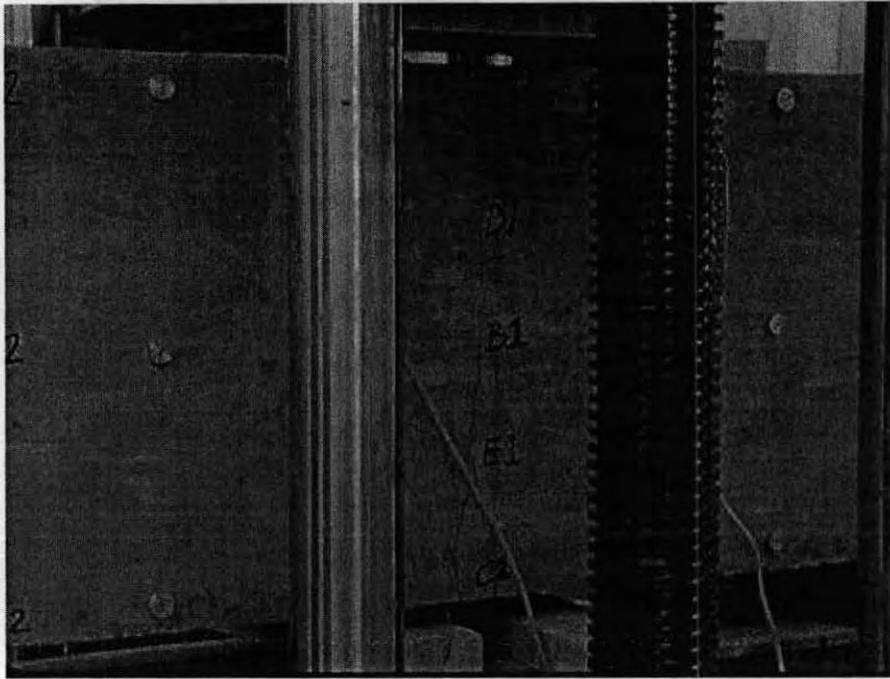
**Photo 17:** Crack in the center of BRC-2 beam due to flexure.
