**Advanced Concept Concrete Using Basalt  
Fiber/BF Composite Rebar Reinforcement**

Final Report for Highway-IDEA Project 86

Vladimir B. Brik,  
Research & Technology Corp., Madison, WI

***February 2003***

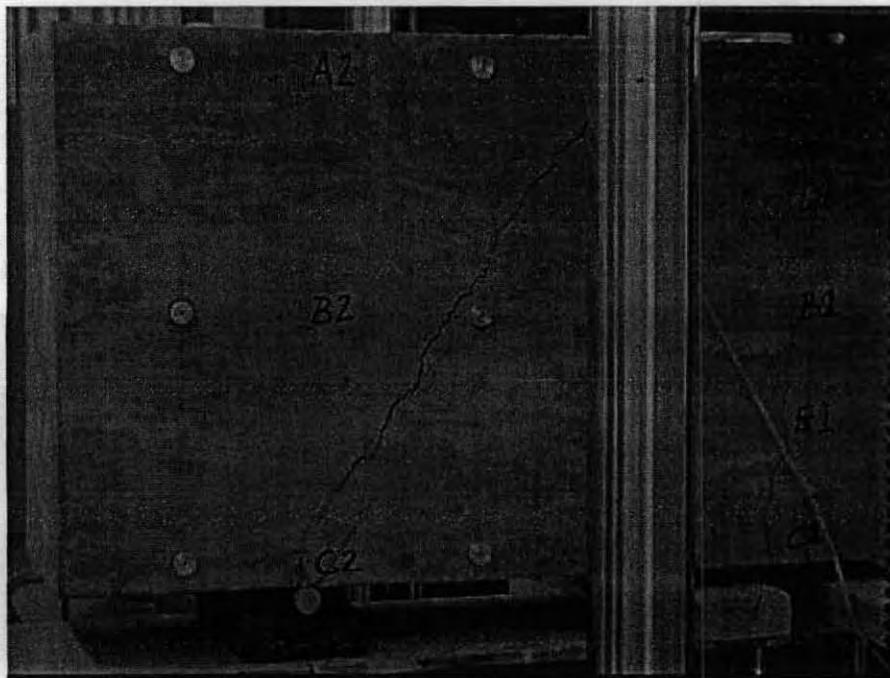
**Photo 18:** Failure of the BRC-2 beam due to shear crack.

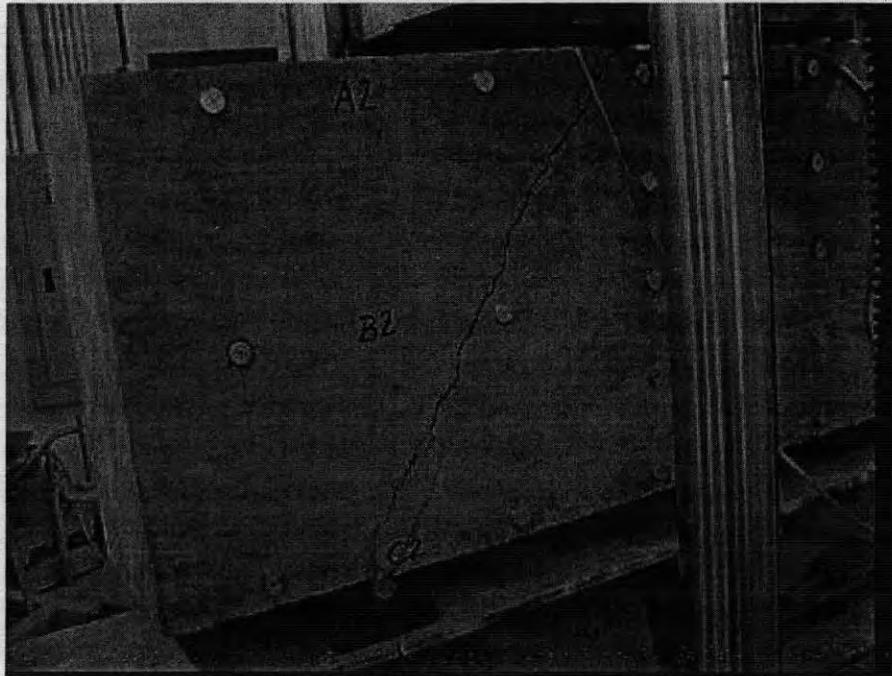
**Photo 19:** View of the failed BRC-2 beam.

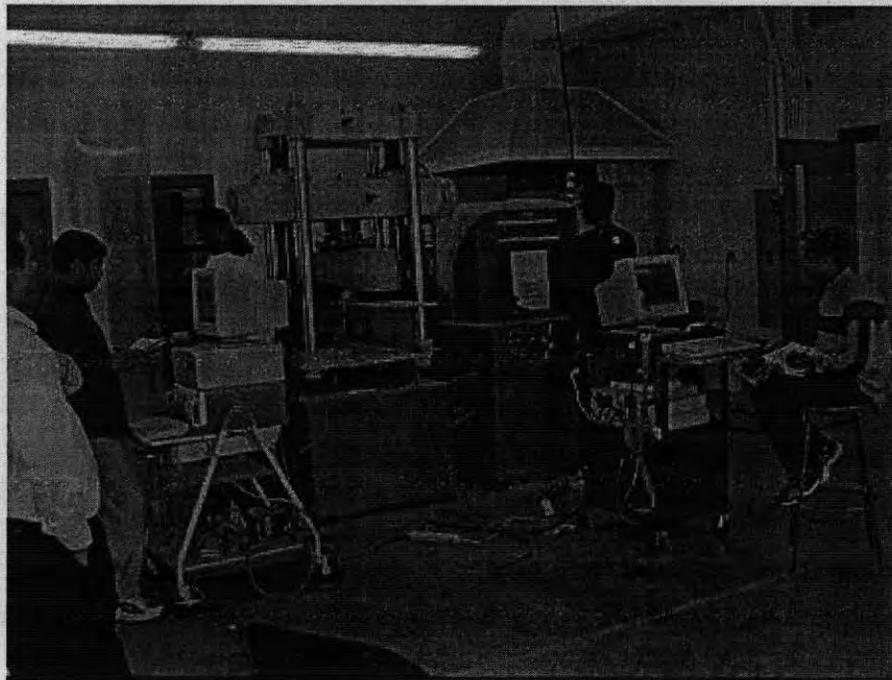
**Photo 20:** Testing under progress.

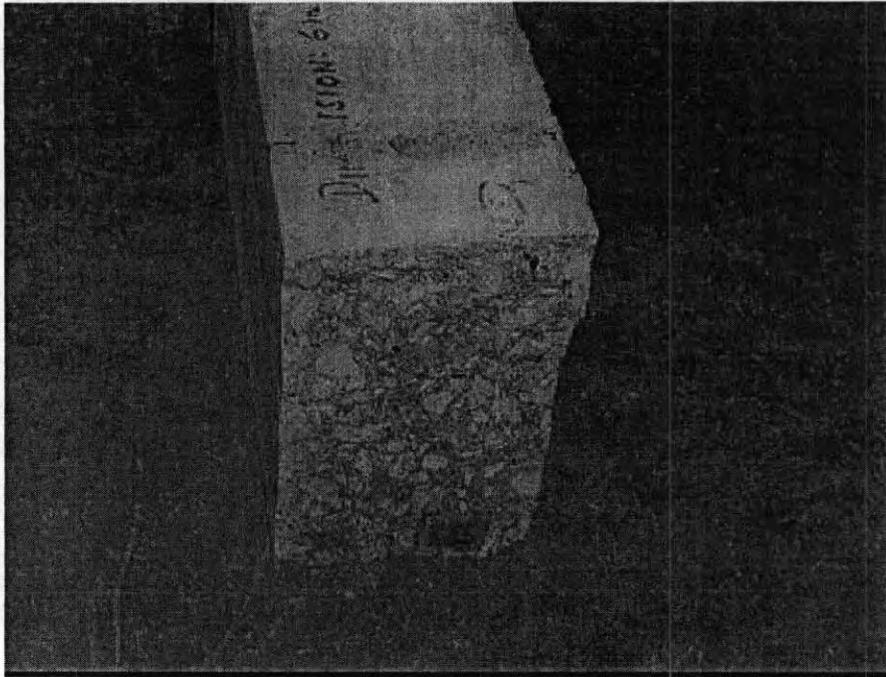
**Photo 21:** Failed BRC-1 beam (after testing).

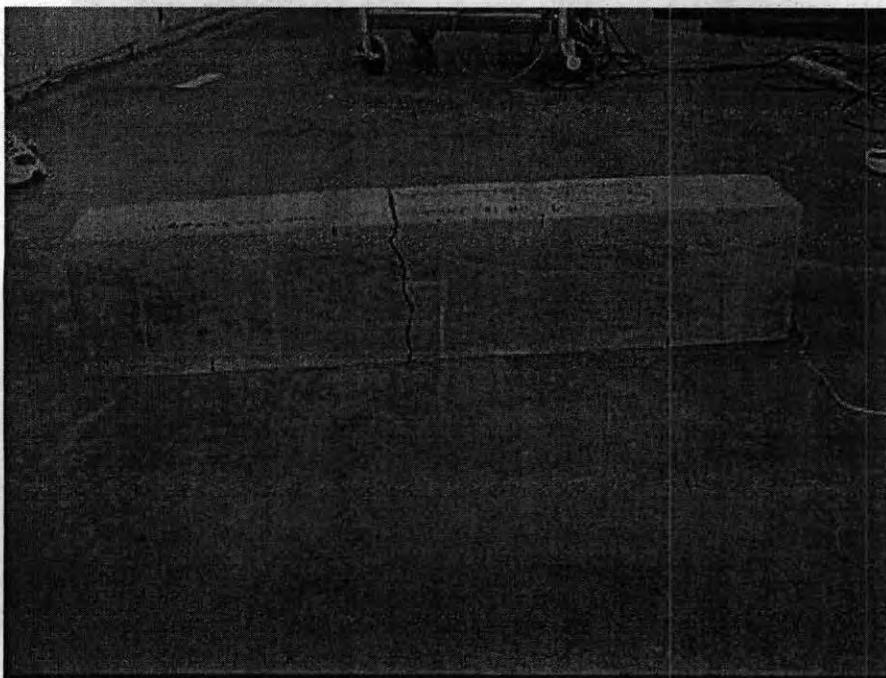
**Photo 22:** Failed BRC-1 beam (after testing).

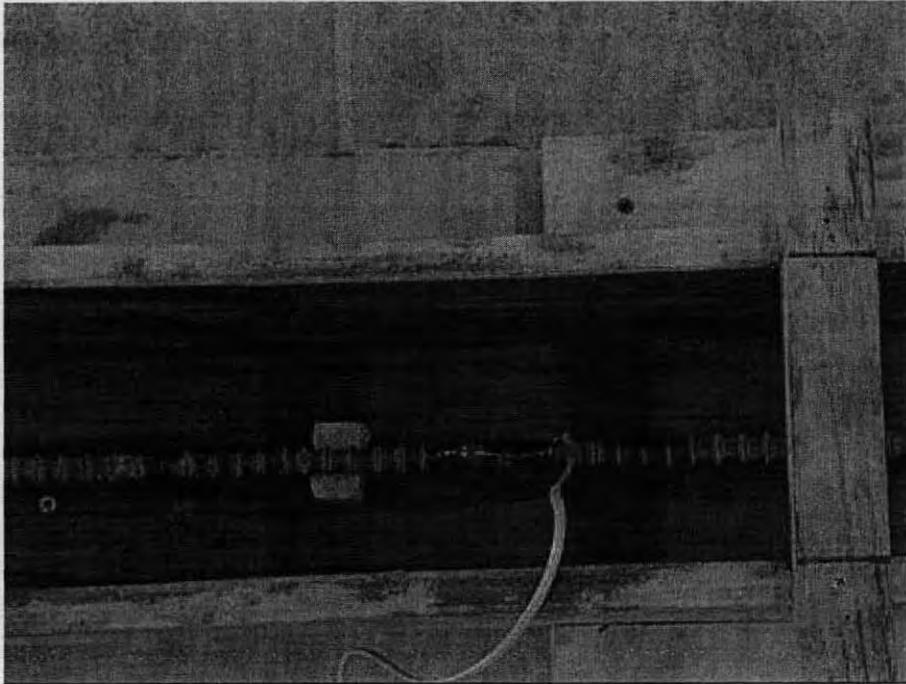
**Photo 23:** BRC -3 beam with single corrugated bar with a strain gauge.

Beam BRC-3 was designed as a lightly under reinforced beam with one corrugated basalt rod 8.6 mm (0.34 in. dia) (Photo 23, Appendix B). Strain gauge was placed on the compression side of the beam for measuring the strain in the concrete. Strain gauge was also placed on the rod (tension side of the beam) to determine the strain in the rebar. The first crack occurred at 95% of the calculated cracking moment (Table 2). After first crack the beam took **2.7 times more** moment than the cracking moment (Table 2) indicating a very good bond strength between the rebar and the concrete. The beam failed at 98% of the calculated ultimate moment (Table 2). The load vs. deflection, the load vs. concrete strain and basalt rebar strain are shown in Figs. 14 to 16 respectively. The beam failed primarily in flexure and secondarily in shear (Photos 24-30, Appendix B).

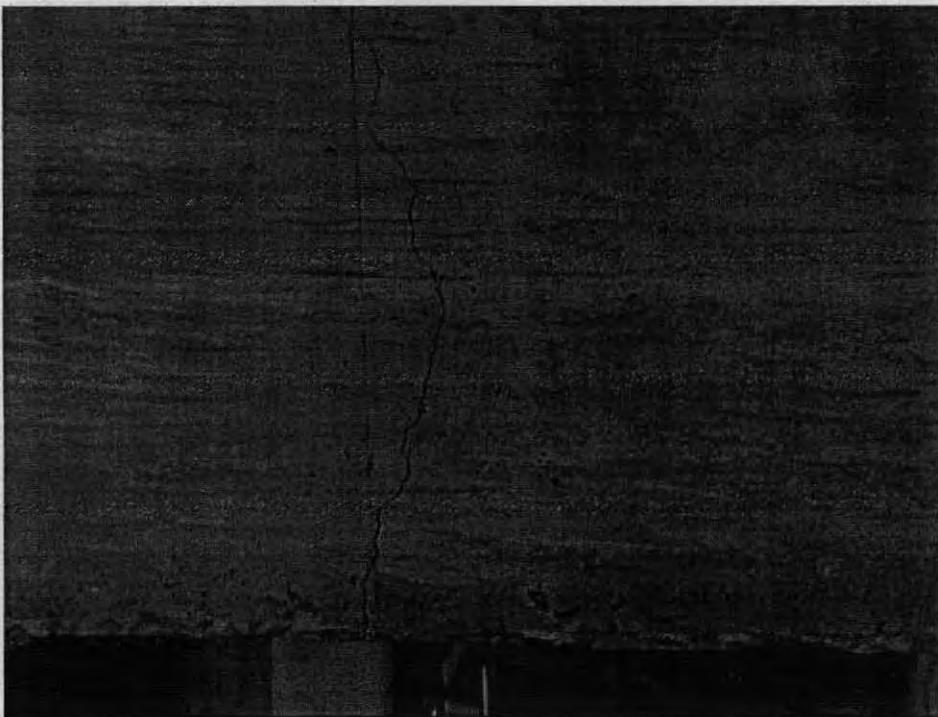
**Photo 24:** First flexural crack of concrete at the center of the BRC-3 beam, the LVDT's for measuring deflections can also be seen.

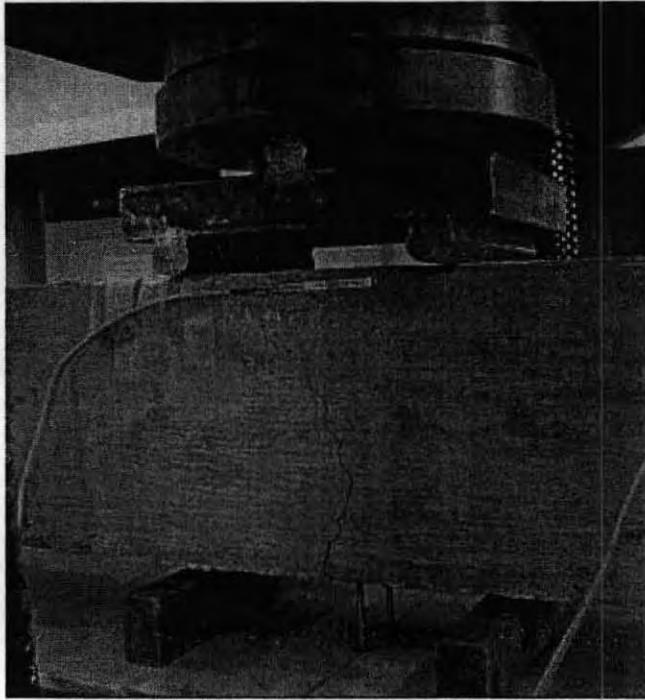
**Photo 25:** Another view of the flexural crack of concrete in the BRC -3 beam. Strain gauge can also be seen in the photograph.

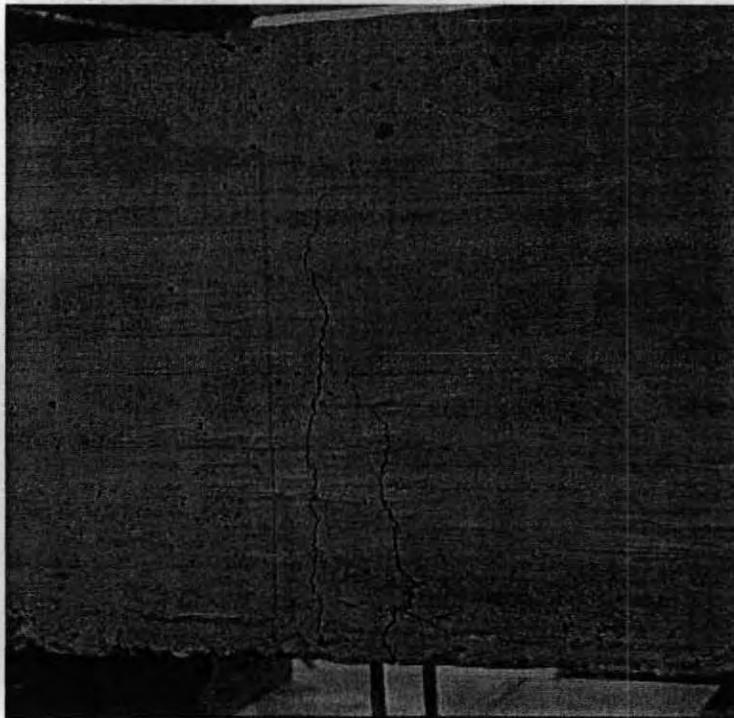
**Photo 26:** Flexural cracks on the other side of the BRC -3 beam.

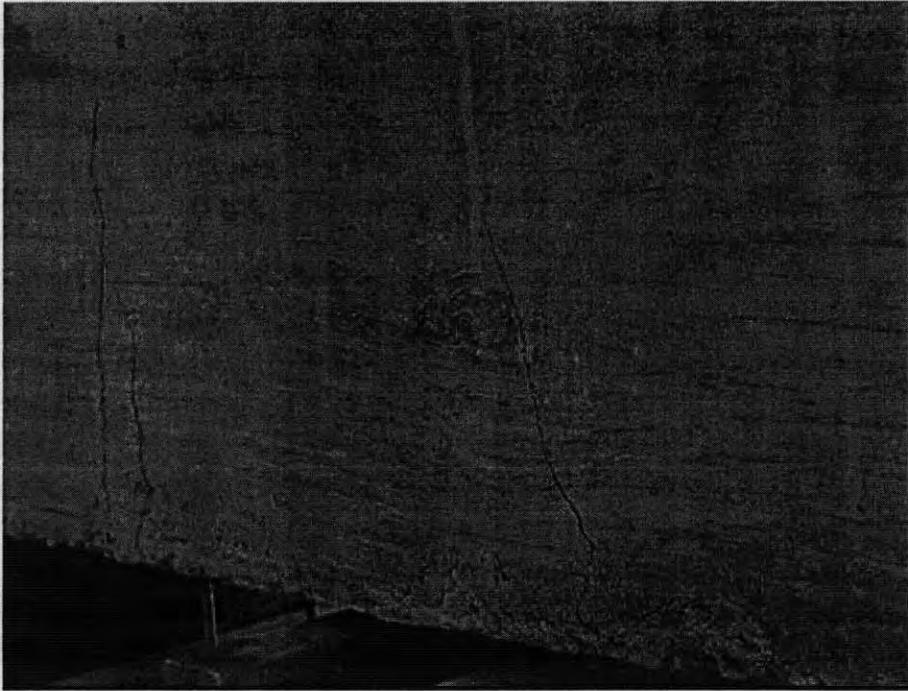
**Photo 27:** Flexural and shear cracks in the BRC -3 beam.

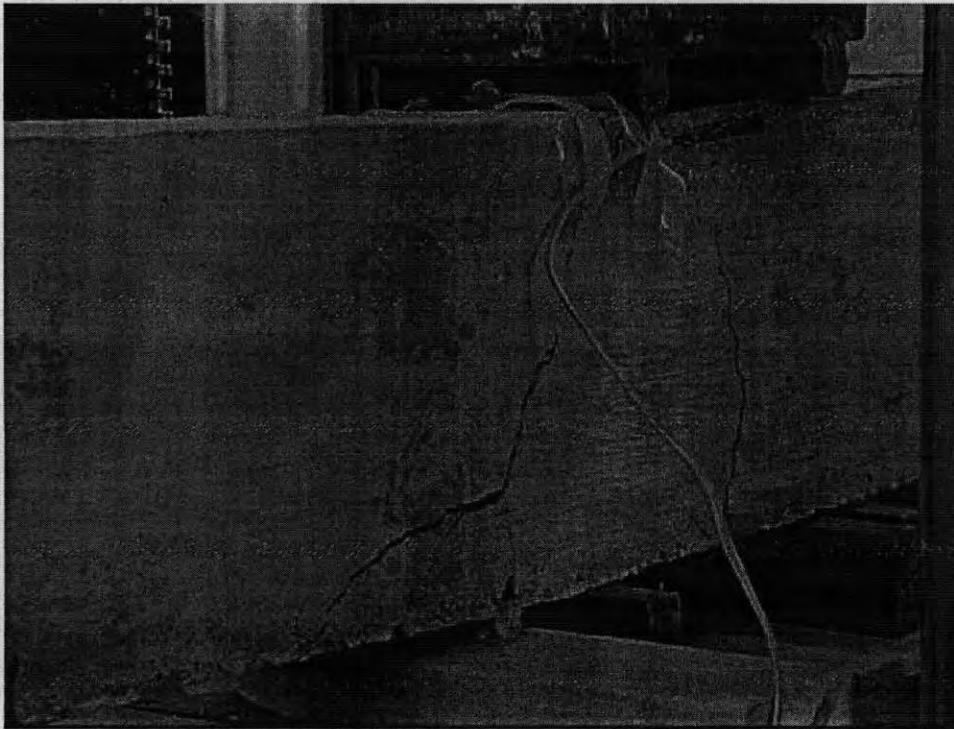
**Photo 28:** Close up of the shear crack in the BRC -3 beam.

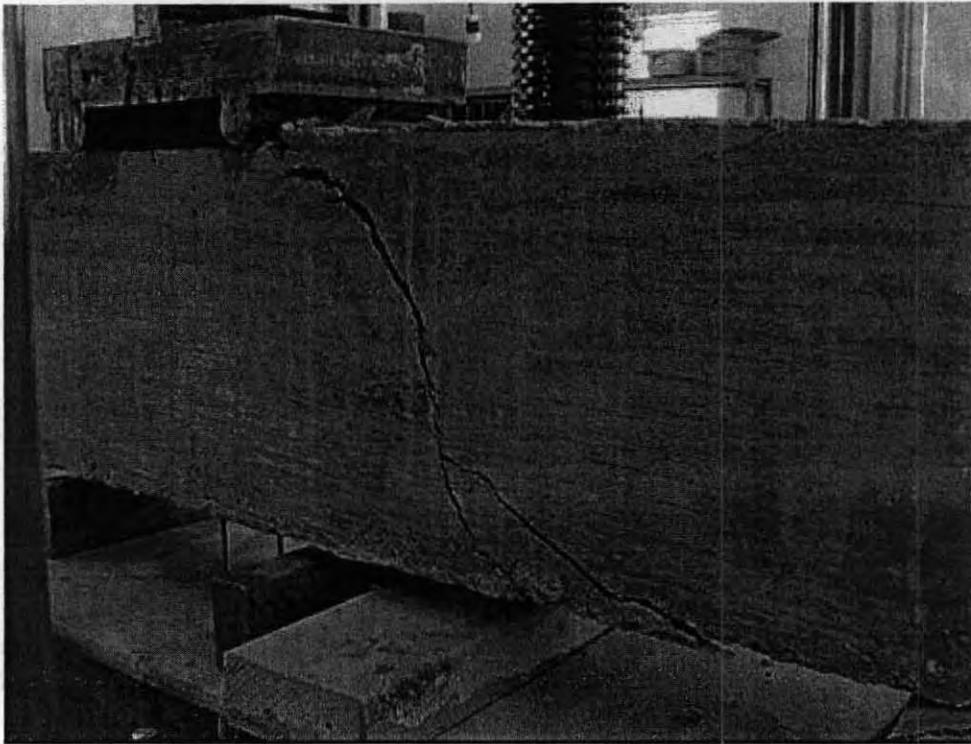
**Photo 29:** Shear crack on the other side of the BRC -3 beam.

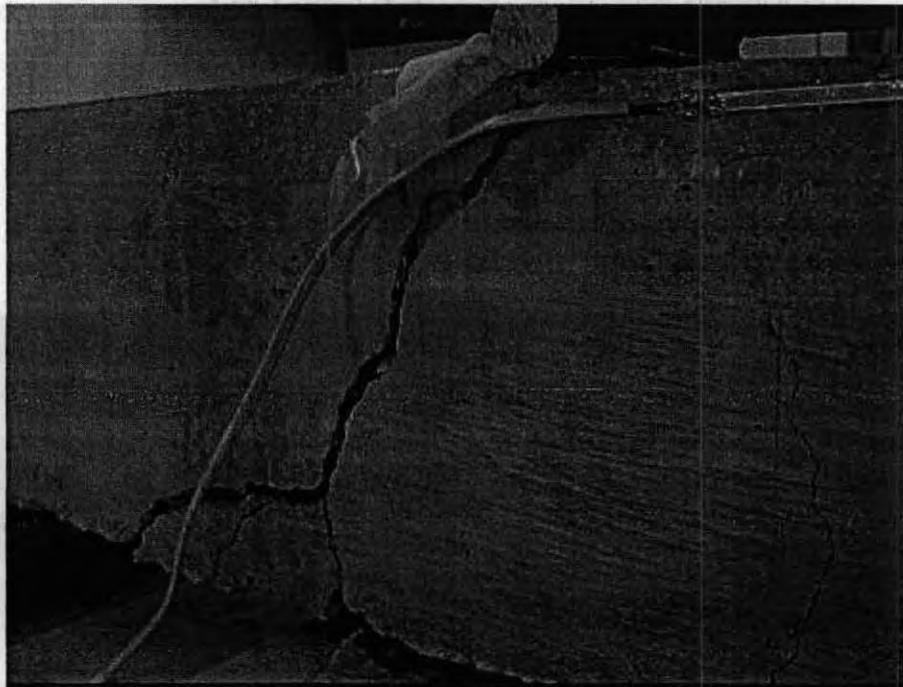
**Photo 30:** BRC -3 beam at failure, the photograph shows that the beam failed by primary flexural failure and secondary shear failure.

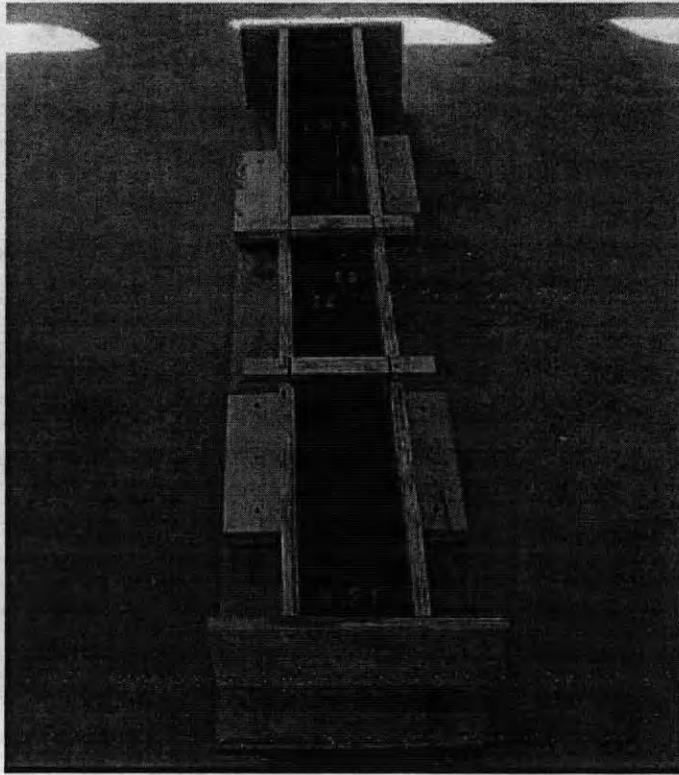
**Photo 31:** BRC -4 beam with two lab twisted cables. Each twisted cable was made by twisting three individual wires of 0.19 inch in diameter in the lab.

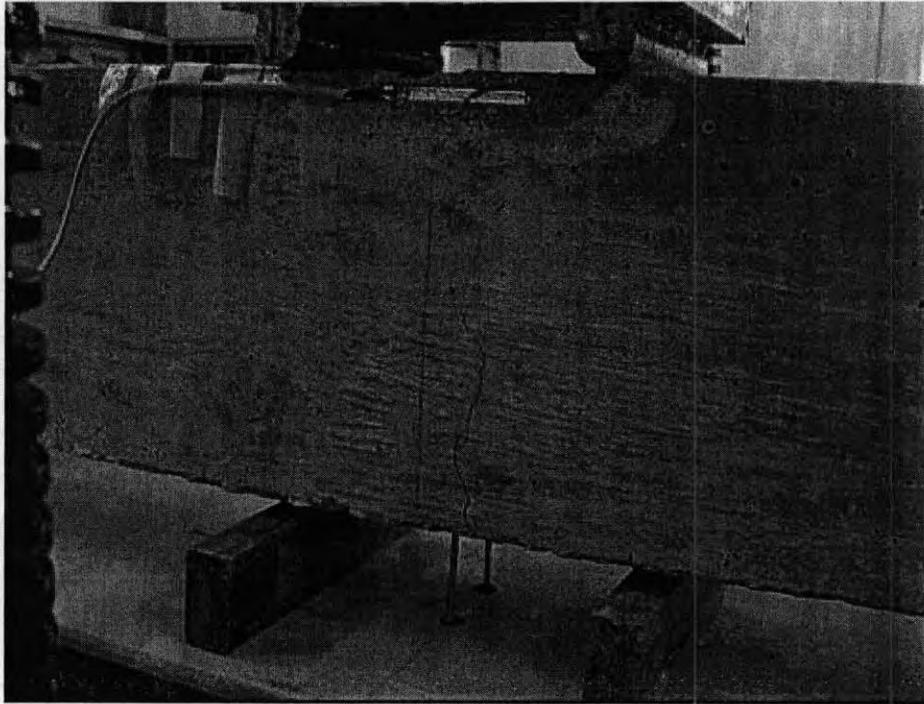
**Photo 33:** View of the flexural crack in the BRC -4 beam.

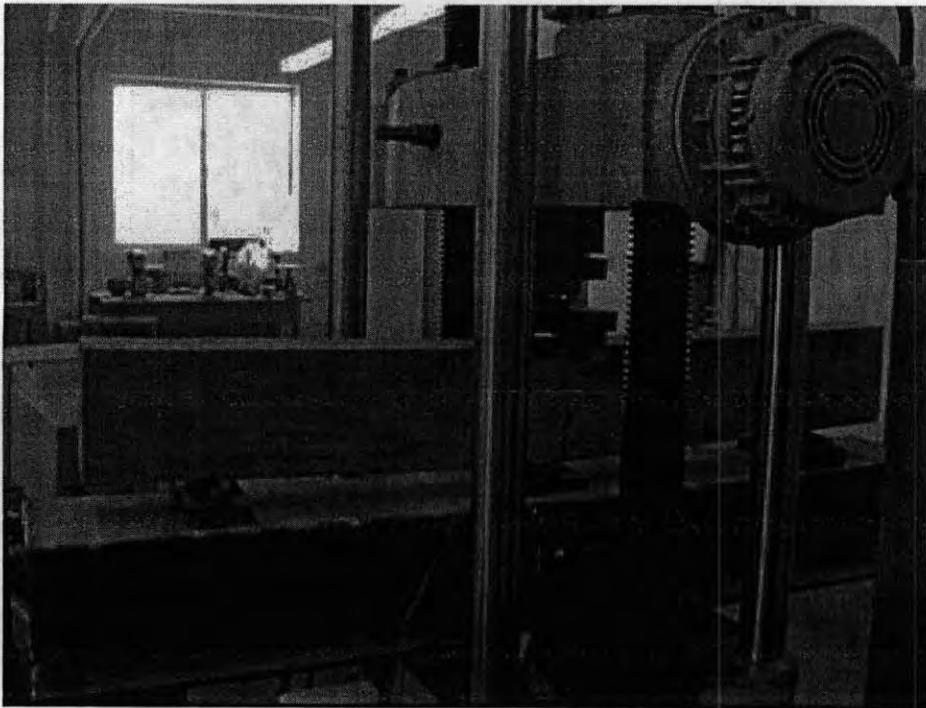
**Photo 34:** Deflected BRC-4 beam with flexural crack, still carrying load.

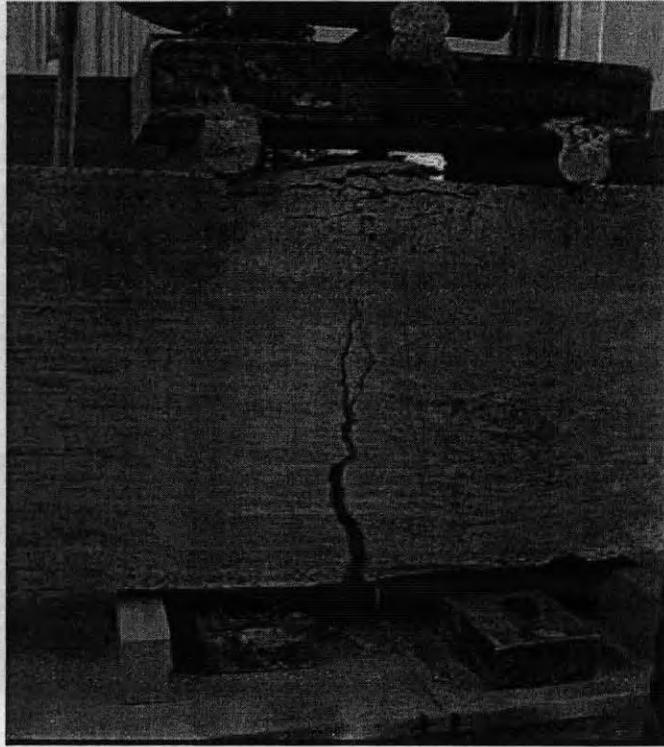
**Photo 35:** Close up of the flexural crack and crushing of the concrete in the BRC -4 beam.

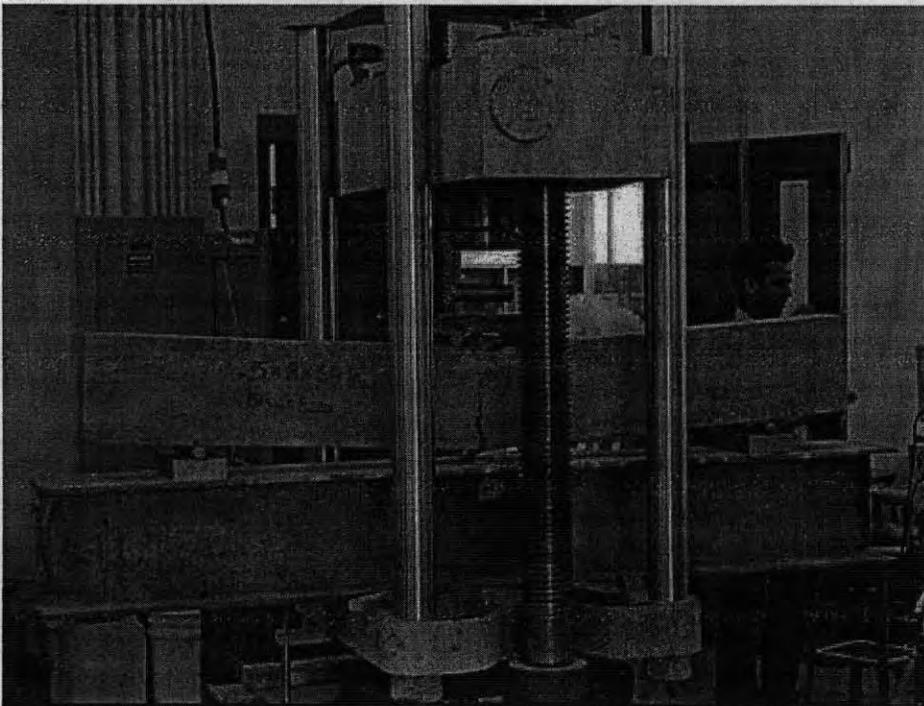
**Photo 36:** BRC-4 beam, at failure. The beam failed purely in flexure.

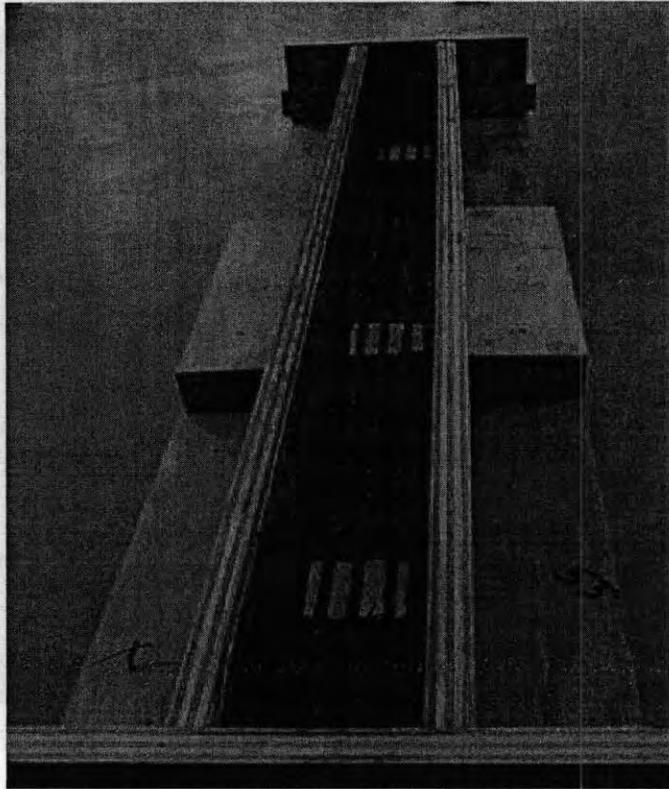
**Photo 37:** BRC-5 beam with three twisted cables ready for casting.

Beam BRC-5 was made of three basalt cables of 1041.4 mm (41 in.) length and 3.45 mm (0.136 in.) diameter (Table 1). The beam was under-reinforced. The cables were supplied by the manufacturer (Photo 37, Appendix B), unlike the one used in beam BRC-4 that was made in the laboratory. A strain gauge was placed on the compression side of the beam, and the strain gauge could not be fixed on the rebar, because of the corrugations formed due to twisting the wires. The beam first had a flexural crack at 95% of the calculated cracking moment (Table 2). After the first crack the beam took **2.4 times more** moment (less than the other beams because it was under-reinforced, and the tensile strength of the bar was also less) than the cracking moment (Table 2) indicating a very good bond strength between the rebar and the concrete. The beam took **49% more** than the calculated ultimate moment (Table 2). The beam failed primarily in flexure and secondarily in shear (Photos 38-40, Appendix B). Overall the performance of the beam was good and the cables completely fractured at failure (Photos 41-42, Appendix B), indicating a good bond strength. The cables did not slip even after the ultimate load was reached. The load vs. deflection and the loads vs. concrete strain are shown in Figs. 19-20 respectively.

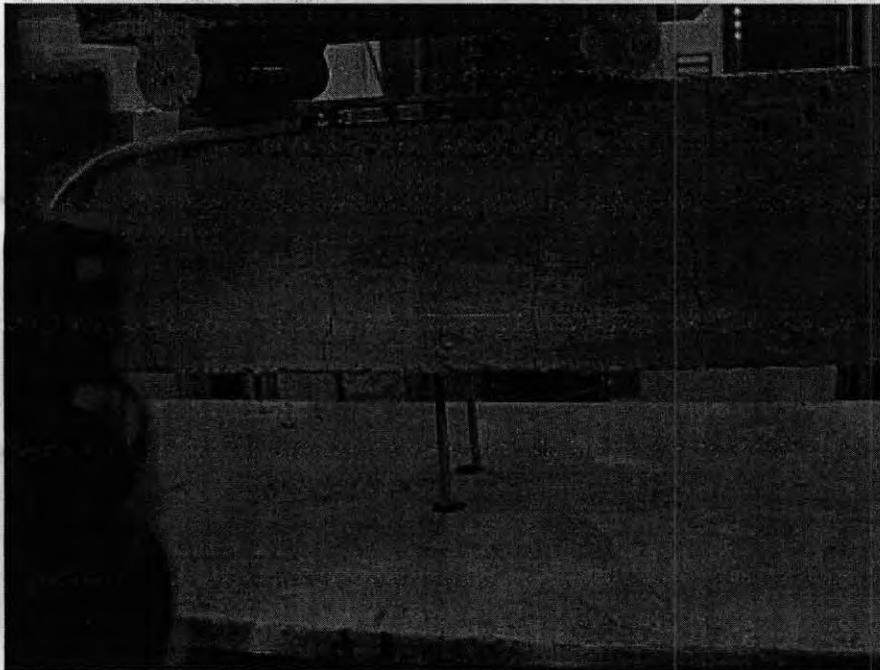
**Photo 38:** BRC-5 beam with flexural cracks. The picture also shows the loading arrangement, strain gauges and the LVDT's.

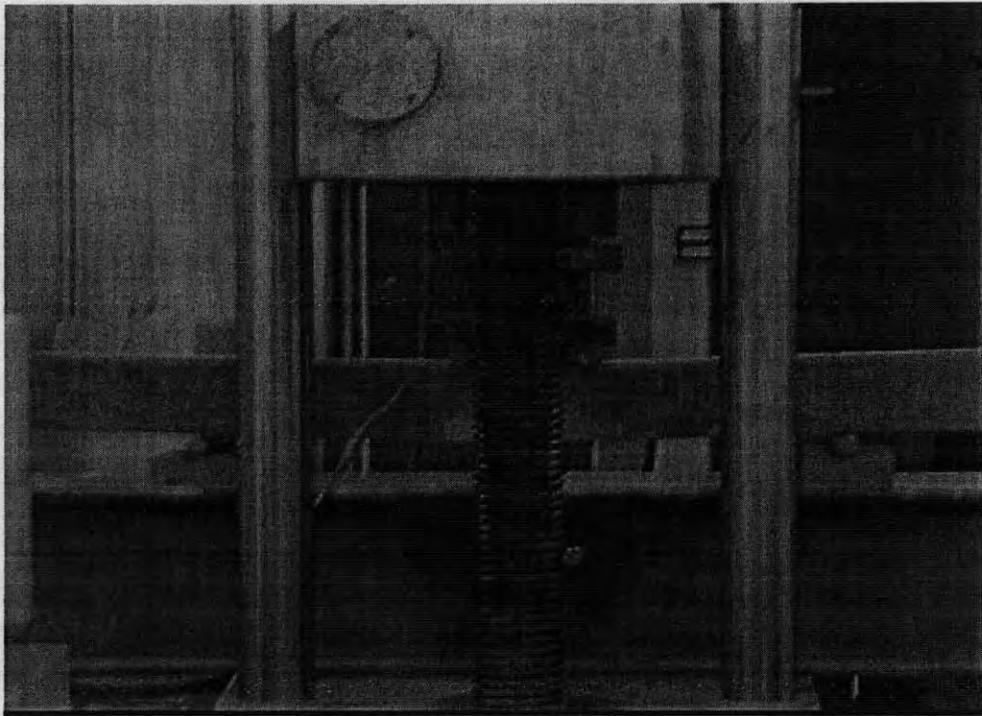
**Photo 39:** The deflected BRC-5 beam still carrying load.

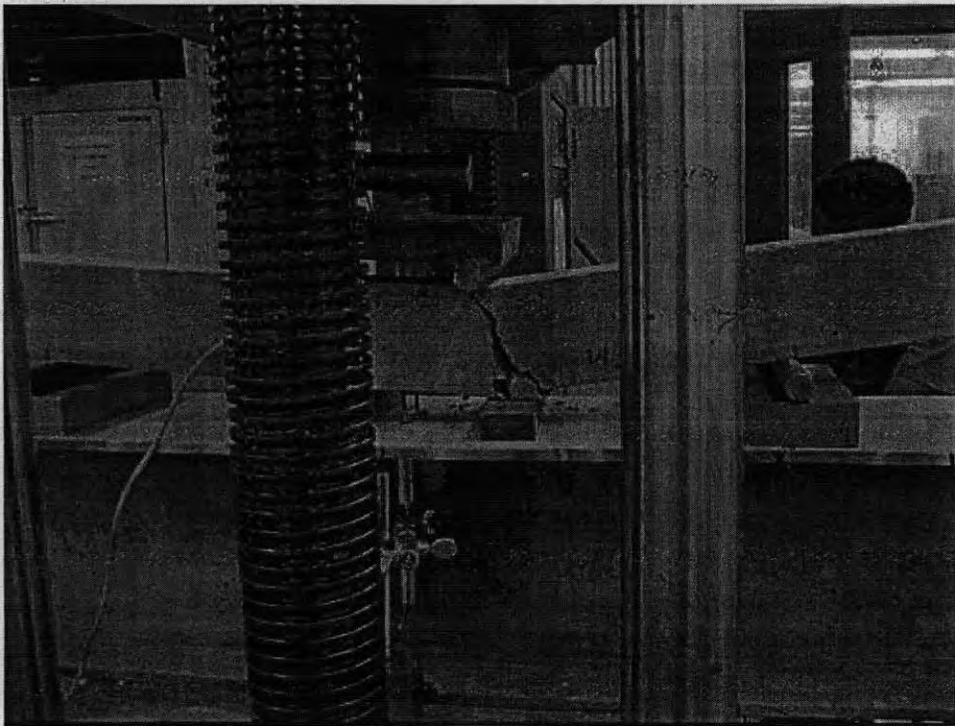
**Photo 40:** BRC-5 beam at failure, the beam failed primarily in flexure and secondarily in shear.

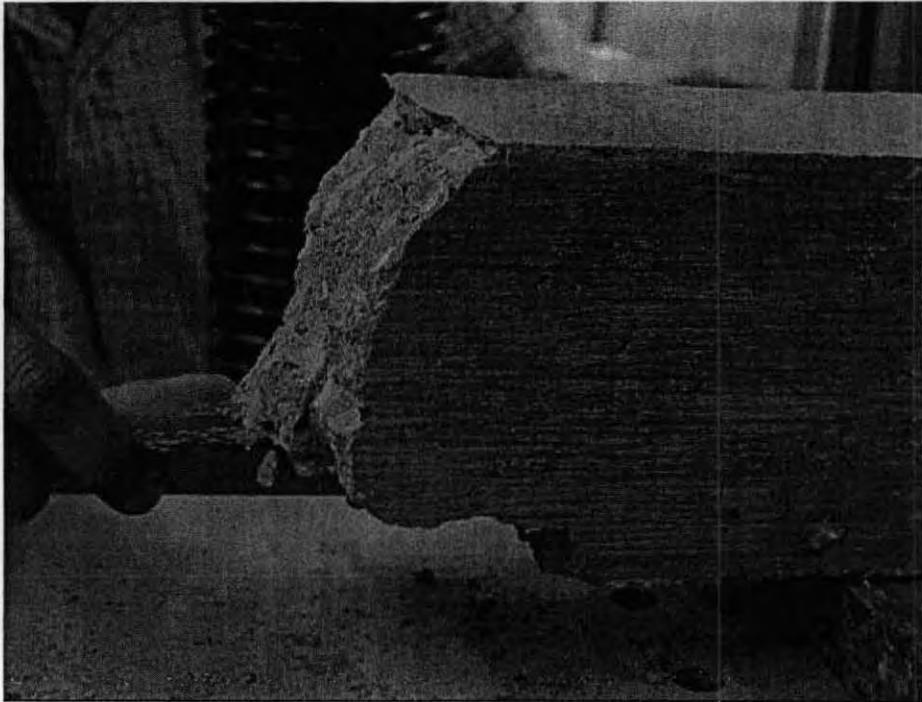
**Photo 41:** Fractured basalt cables, the cables had split into two indicating that there was a good bond between the concrete and the cable.

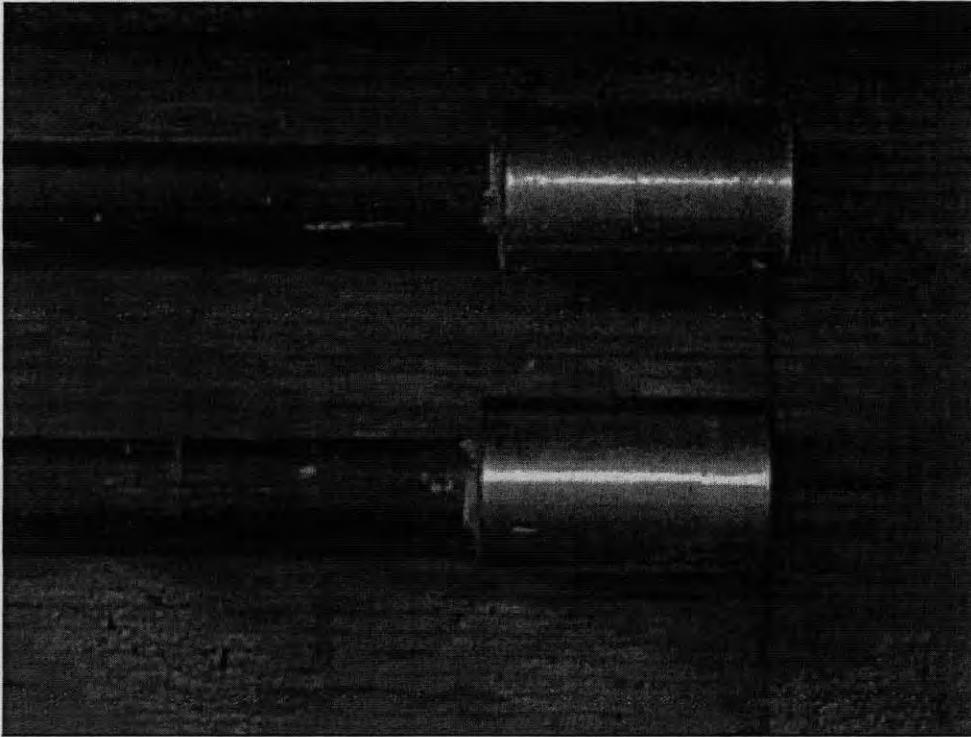
**Photo 43:** Close-up of the basalt rods with Fe-Mn-Ni anchors, one on each end of the bar for the BRC-6 beam. The anchors are smart alloys, which were provided to improve the bond strength.

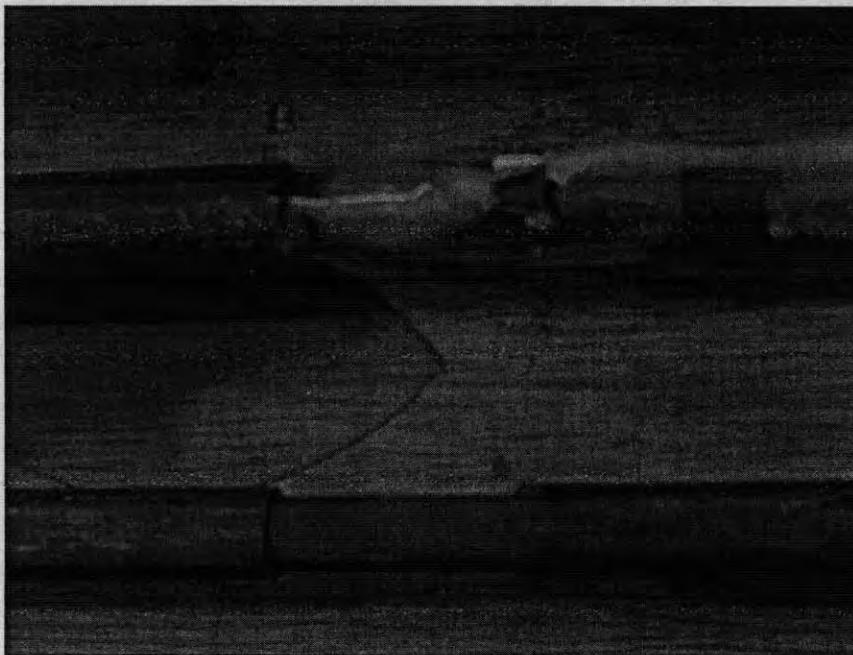
**Photo 44:** Strain gauge fixed to the basalt rods on the slots. Two slots were provided in each bar to improve the bond strength. The strain gauge was covered by epoxy to protect it from damages while casting the beam.

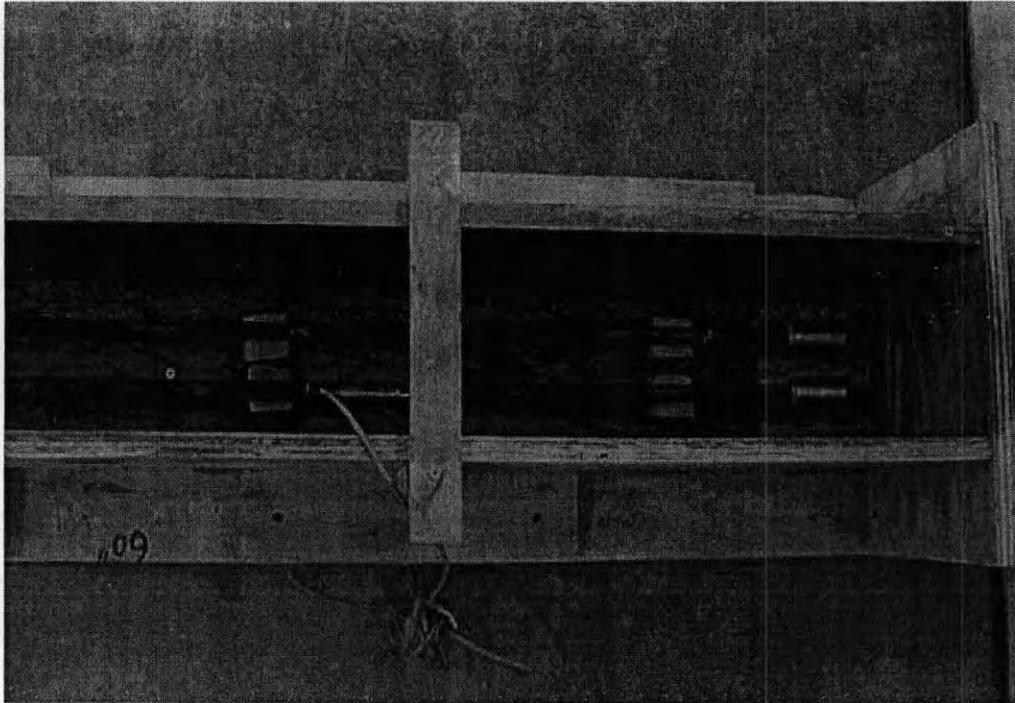
**Photo 45:** BRC-6 beam with basalt rods, fixed with Fe-Mn-Ni anchors and strain gauge, ready for casting.

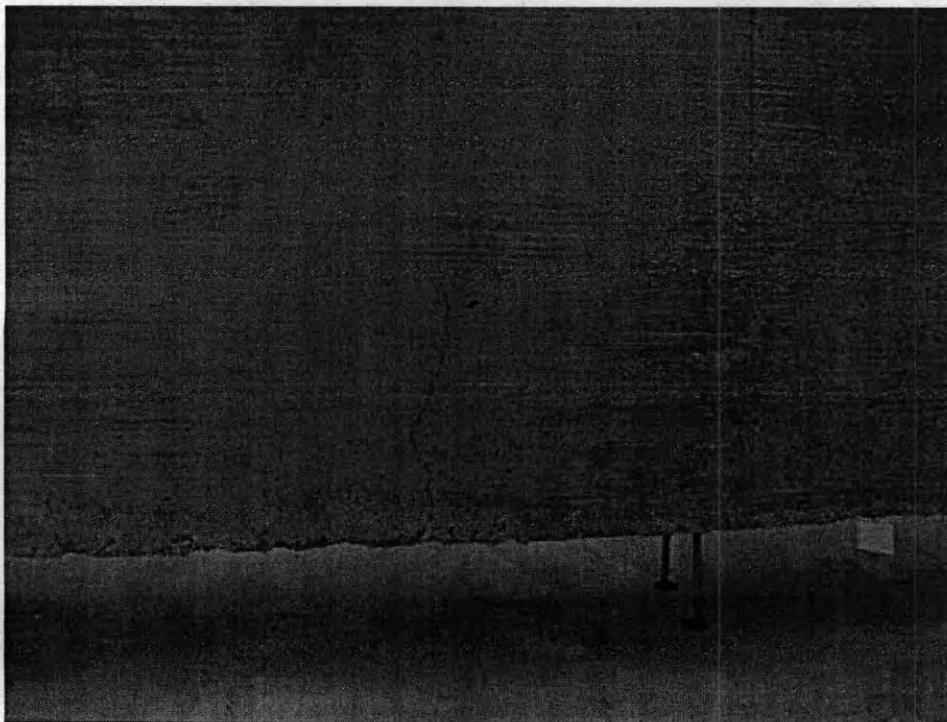
**Photo 46:** BRC-6 beam with flexural crack. LVDT's are also seen.

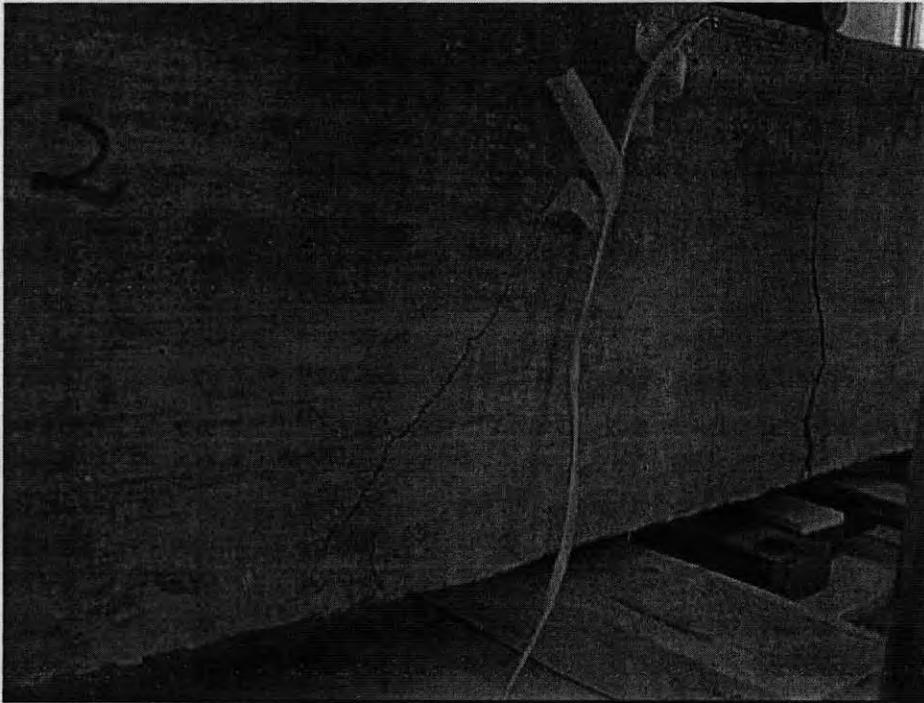
**Photo 47:** Another view of the BRC-6 beam with flexural and shear cracks.

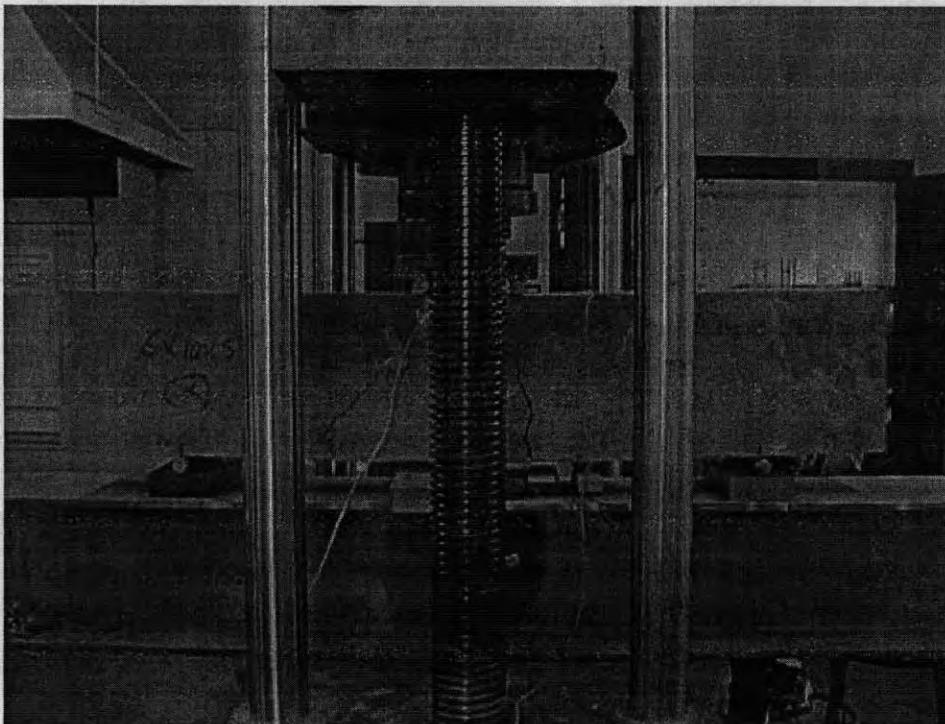
**Photo 48:** Deflected BRC-6 beam with flexural and shear cracks still carrying load.

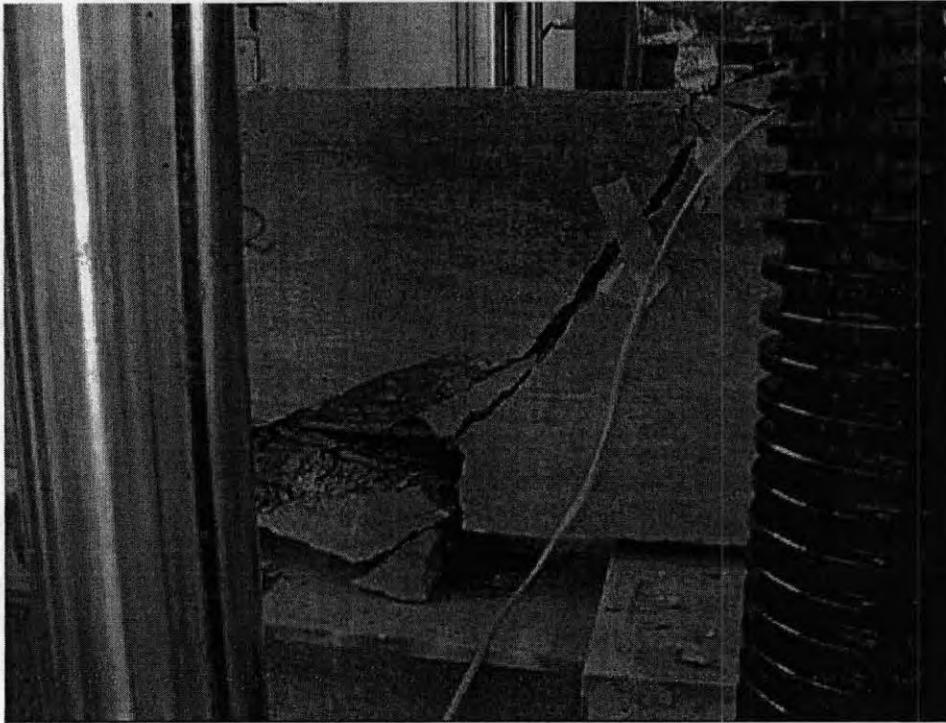
**Photo 49:** BRC-6 beam at failure. The close-up of the shear crack and the basalt rod are also visible.

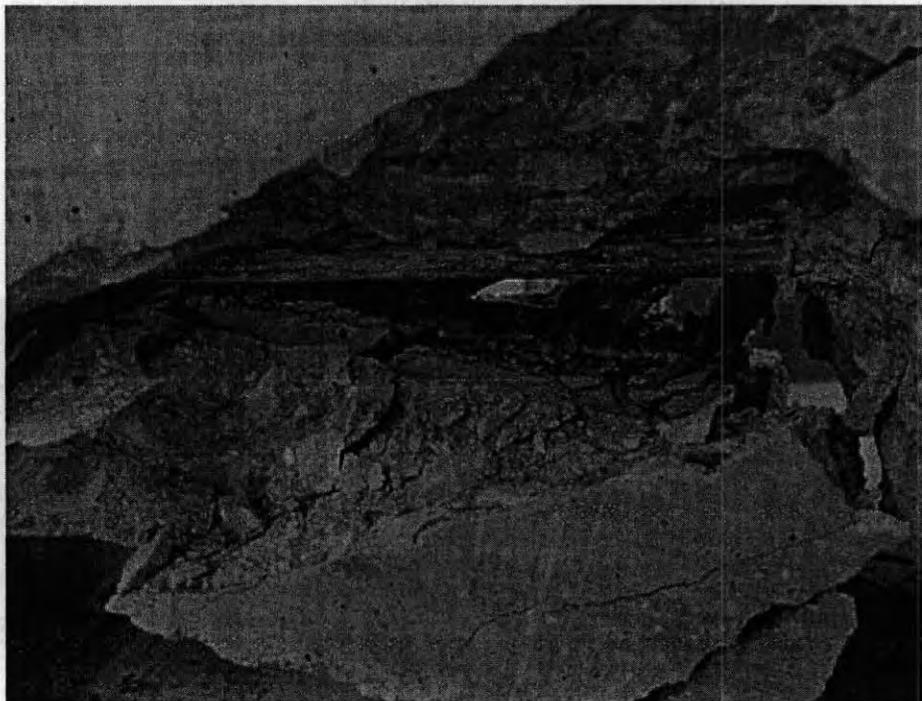
**Photo 50:** Close-up of the crack. The rod impressions in the concrete shows that the rod did not slip.

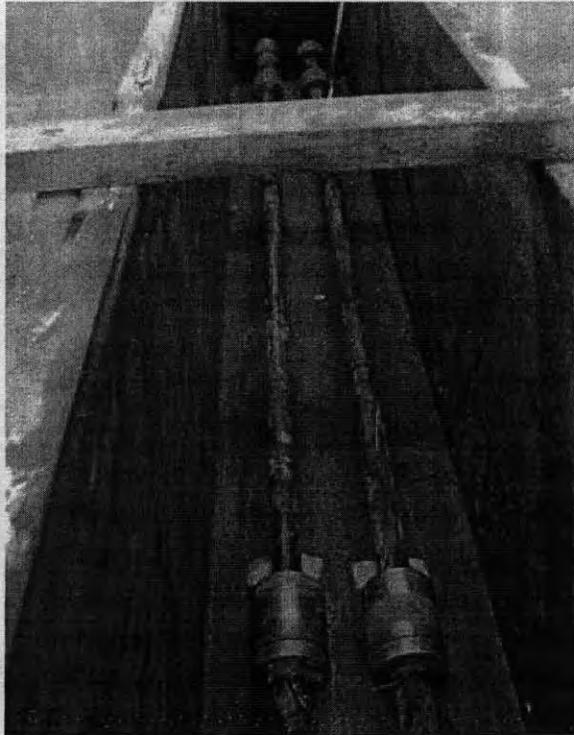
**Photo 51:** The basalt rods with TiNi (50/50) anchors for the BRC-7 beam. The bars were held in position by concrete cover and ties. Two slots (visible in the picture) were provided in each rod to improve the bond strength

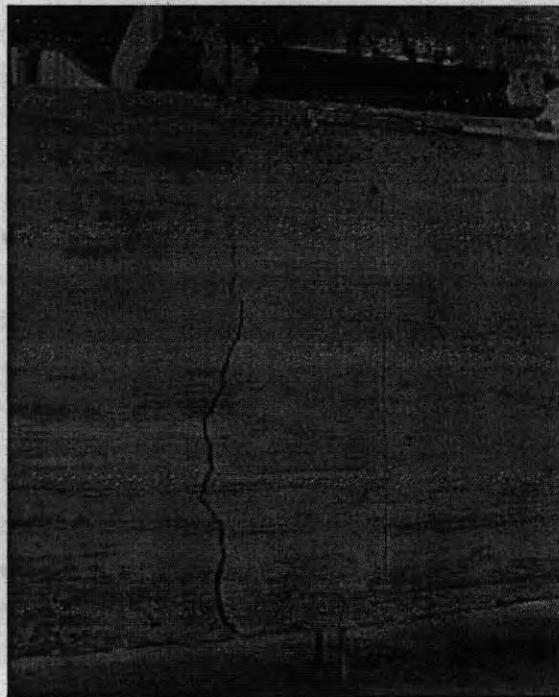
**Photo 52:** BRC-7 beam with flexural crack (first crack). The picture also shows the strain gauges fixed at the top of the concrete beam (compression side).

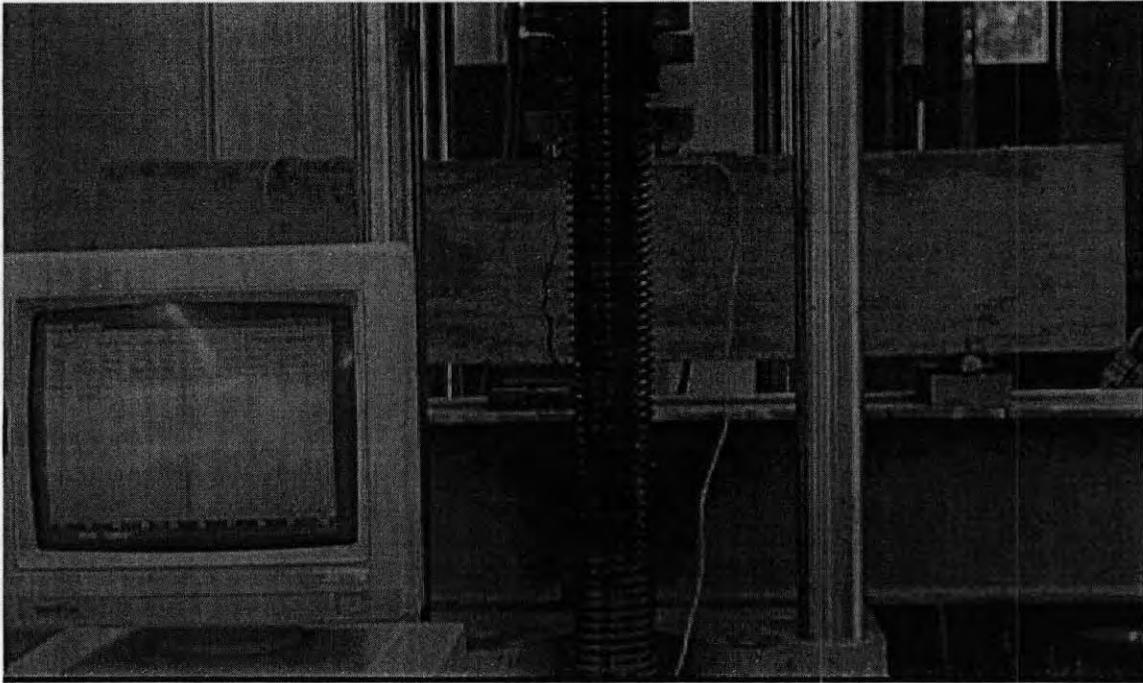
**Photo 53:** Deflected BRC-7 beam with flexural crack still carrying load. The MEGADAC data acquisition system for recording strain readings is also seen.

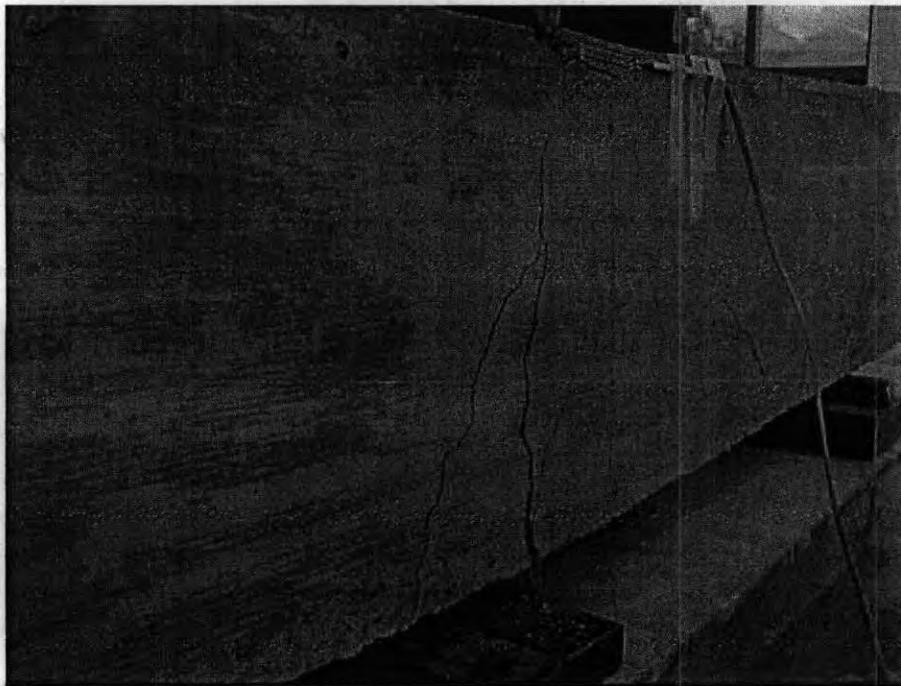
**Photo 54:** BRC-7 beam with flexural and shear cracks. The crushing of concrete at the point of loading is also seen.
