**Advanced Concept Concrete Using Basalt  
Fiber/BF Composite Rebar Reinforcement**

Final Report for Highway-IDEA Project 86

Vladimir B. Brik,  
Research & Technology Corp., Madison, WI

***February 2003***

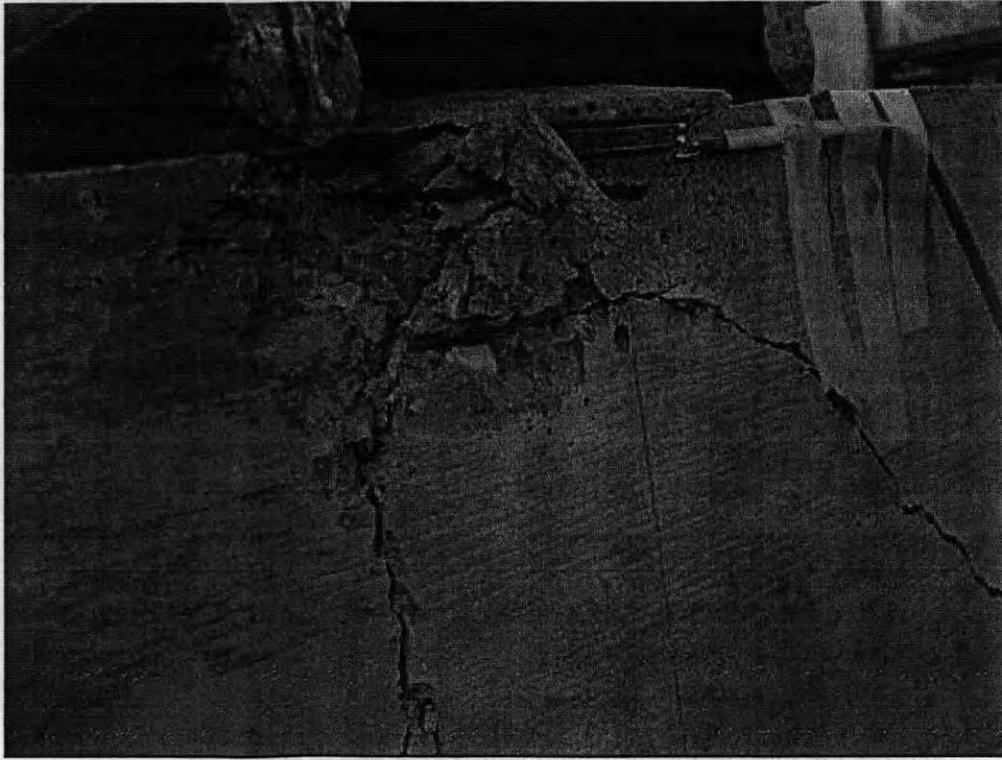
**Photo 55:** Crushing of concrete at the point of loading.

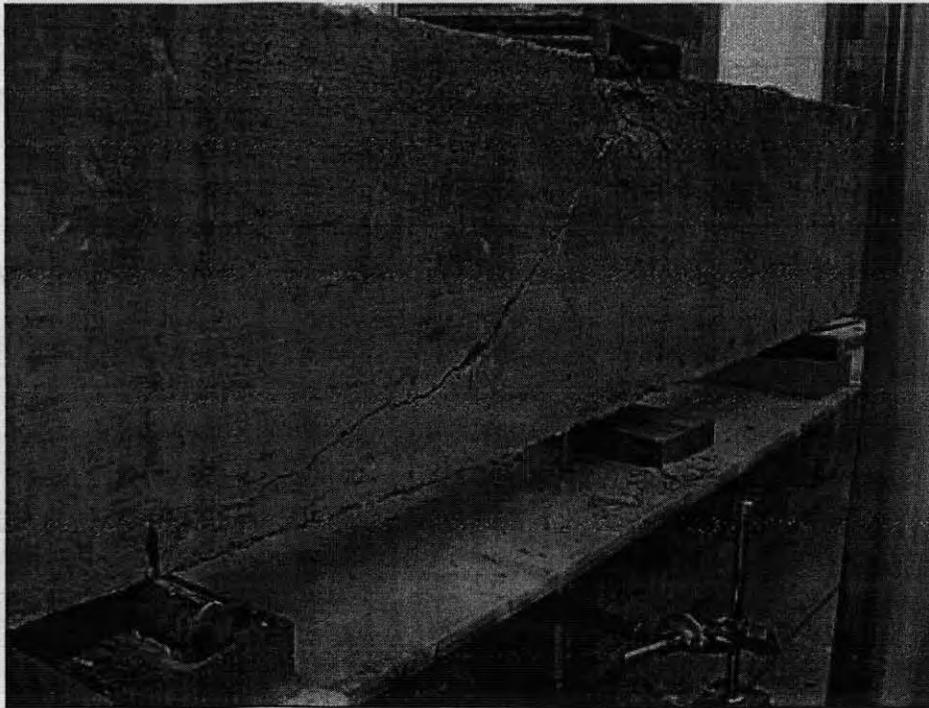
**Photo 56:** Shear crack in the BRC-7 beam with rods fixed with smart alloys anchors. The beam had failed primarily in flexure and secondarily in shear.
